# Updated - Technical Service Bulletin

SUBJECT: REMEDIAL PROCEDURE TO ADDRESS POSSIBLE OXYGEN LEAKS FROM CONTROL VALVES

BULLETIN NO.: TSB 2018-01 (Revised)

AFFECTED MODEL(S): **BR22 PLUS** EXOTHERMIC CUTTING TORCH

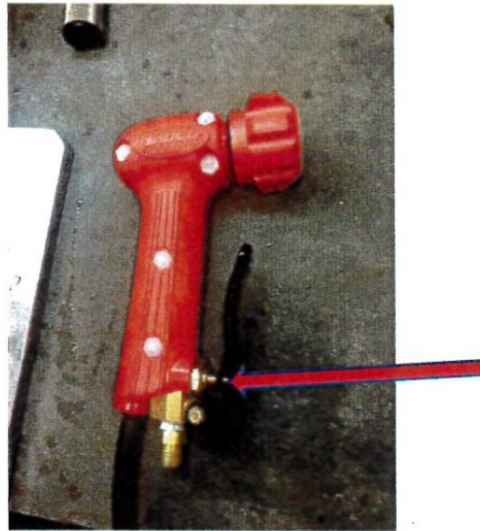
A recent report of an external oxygen leak from the control valve of a **BR22 PLUS** prompted an investigation to determine root cause. The result of that investigation concluded that machining debris in the O-ring groove of the Control Valve Nut has interfered with the oxygen seal in the valve assembly. There may be additional **BR22 PLUS** torches out in the marketplace that could also leak at the control valve stem while the valve lever is depressed. We do not believe this to be a safety issue due to the leak volume and location. Because Broco-Rankin accepts nothing less than quality in the hands of our customers, we are providing this notice to notify the appropriate parties of the next steps.

- The picture below shows what a BR22 PLUS torch looks like and the location of the valve stem leak. If this is not what your torch looks like, do not continue!

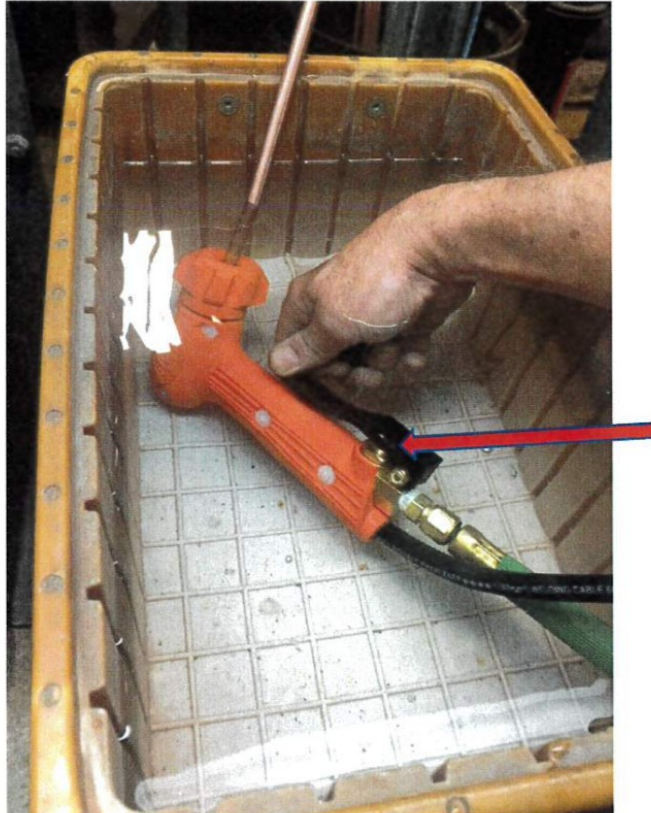
- Set oxygen pressure to 180psi (double that of normal operating pressure) and submerge the entire BR22 PLUS torch under water in a suitable container of your choice with the end of the cutting rod raised above the water to exhaust the oxygen gas. Be sure that the valve section is submerged at least 2" below the water surface for clear detection of any possible oxygen leaks.
- Keep the BR22 PLUS submerged for about 30 seconds before carrying out the next steps. You will likely see some bubbles here from air pockets inside the torch body.
- With the end of the rod raised above water, depress the valve lever with a 2 second count and while doing so, inspect the valve stem area (shown in the picture with a red arrow) for any steady stream of bubbles. Repeat this step 5-10 times.

- If the stream of bubbles is present, please remove the BR22 PLUS torch from service and contact Broco-Rankin. If there are no visible leaks, please resume use of the product as intended.
