Belize Water Services Assignment

ASSIGNMENT WITH BELIZE WATER SERVICES LIMITED REPORT

FEBRUARY 16 – MARCH 4, 2019

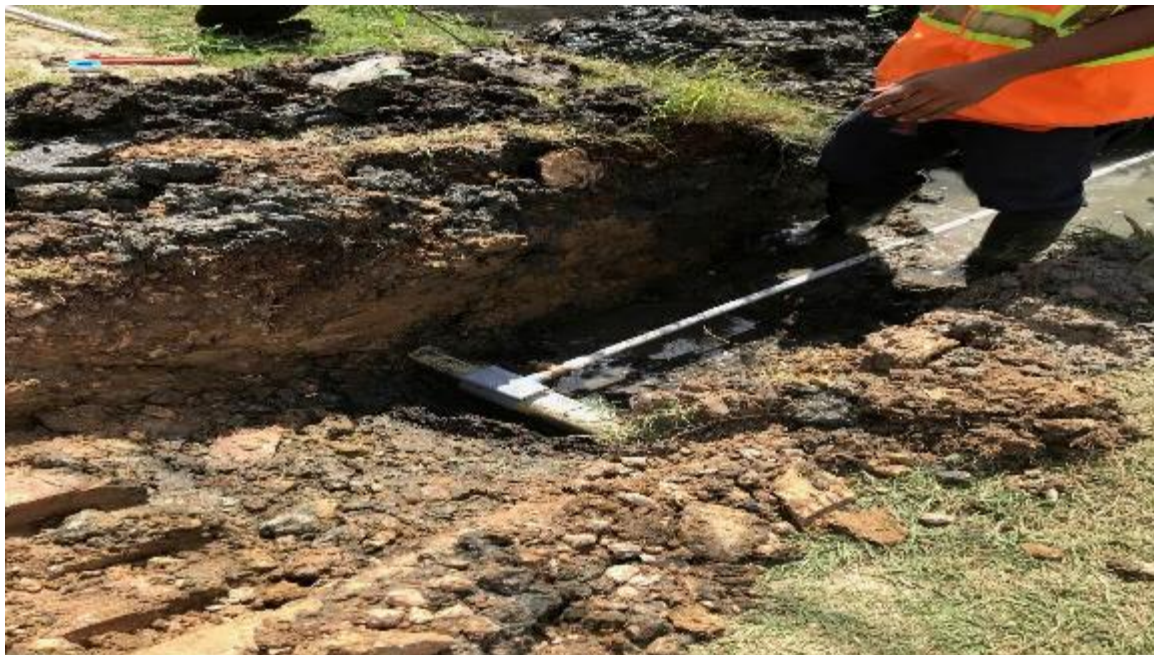
New connection in Belize City.

Practice of installing caution tape above mains the mains and services and tracer wire is crucial and must be repeated on every installation to ensure ease of location for future repairs

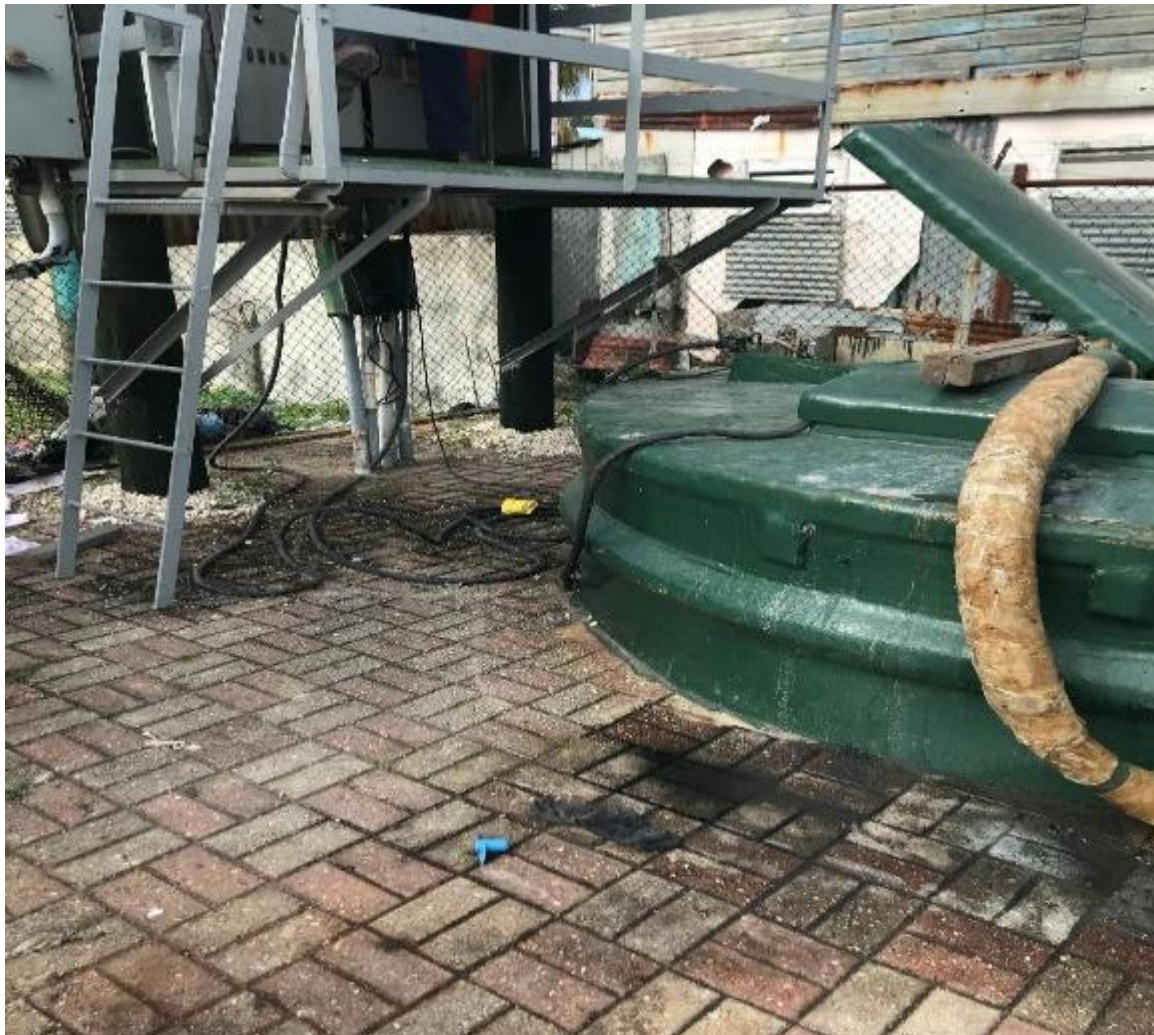
The wastewater pumping stations were the area of most concern during our tours. All locations seemed to have the same concerns. It appeared that many of the stations were not being operated as designed. It was noted that several stations were using by pass pumps due to failures with either valves, check valves or piping within the wet wells.

Station S6 – Note this station is presently being repaired.

Repairing the valves, check valves and internal piping would be the first step in returning the stations to the designed operation.

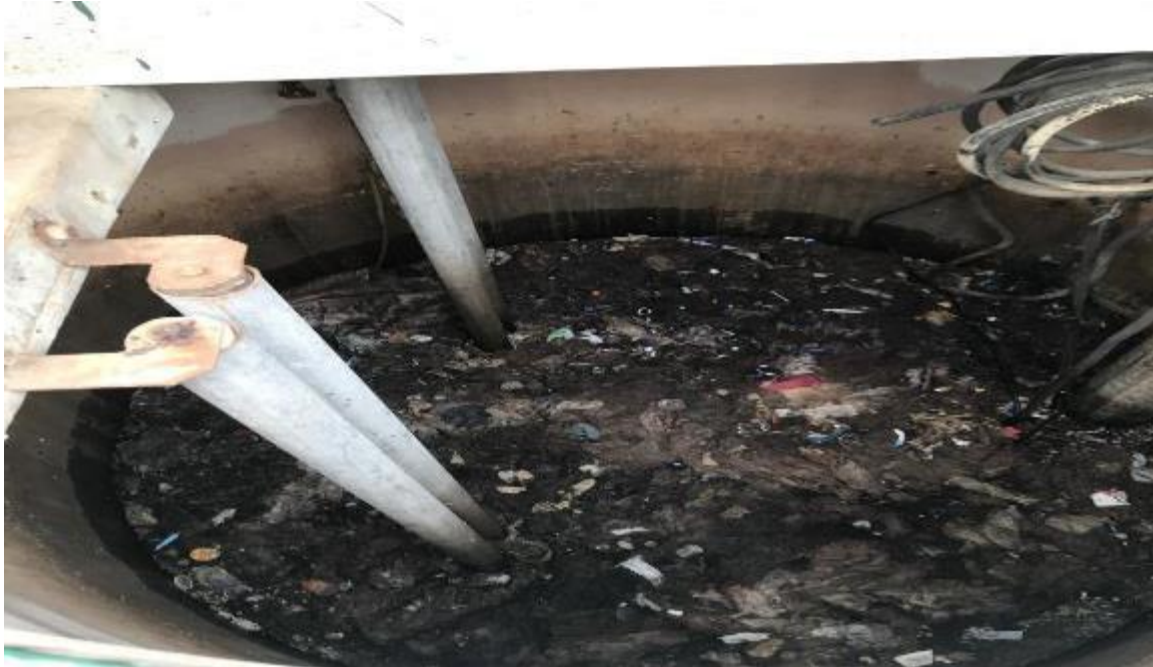
Station operating at overflow level.

Returning the stations to operational design will allow the stations to transfer both liquid and solids to the treatment plant. Floats will need to be checked for proper operation to allow the pumps to turn on and off, cycling the station as per design.

Presently there is no alarming system for the lift stations. By installing one more float for high level, an operator could be notified before the station goes to over flow. We recommend a simple auto dialer system such as the Protalk system <http://www.barnettprotalk.com>

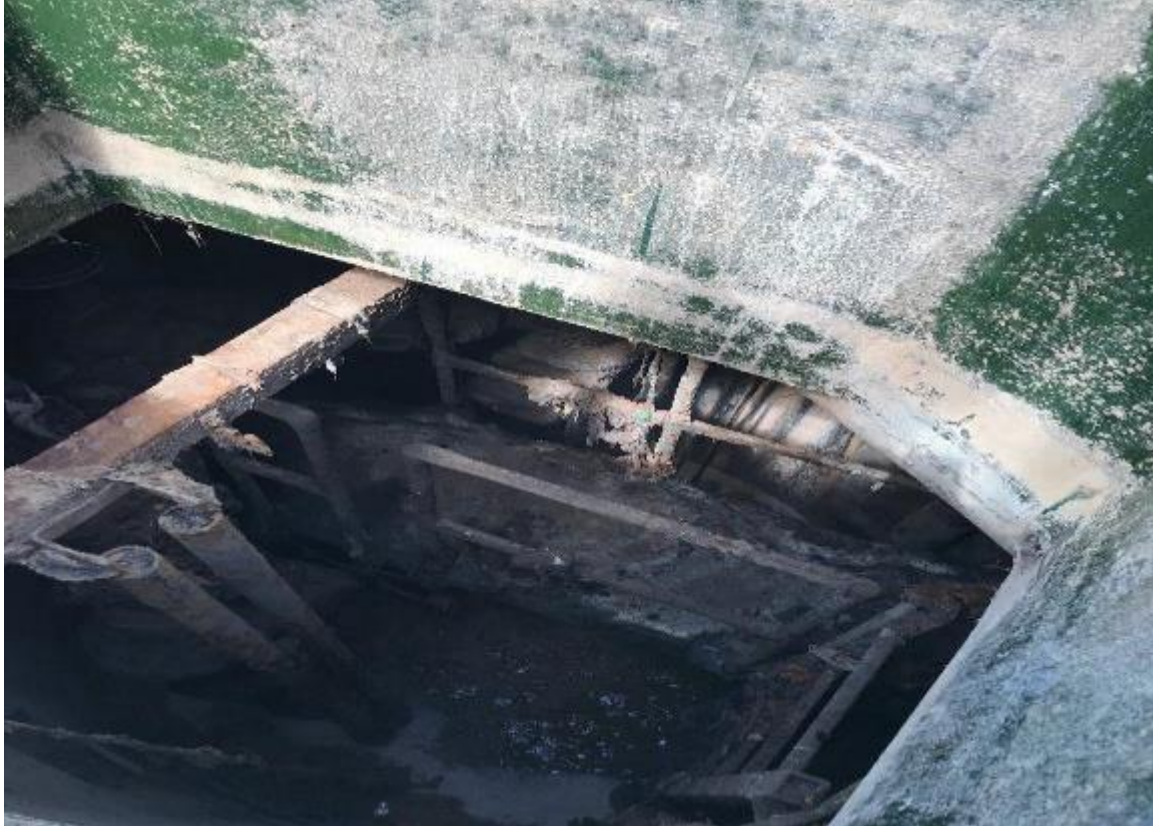
Note: the debris on the catwalk may have deteriorated the integrity of the structure.

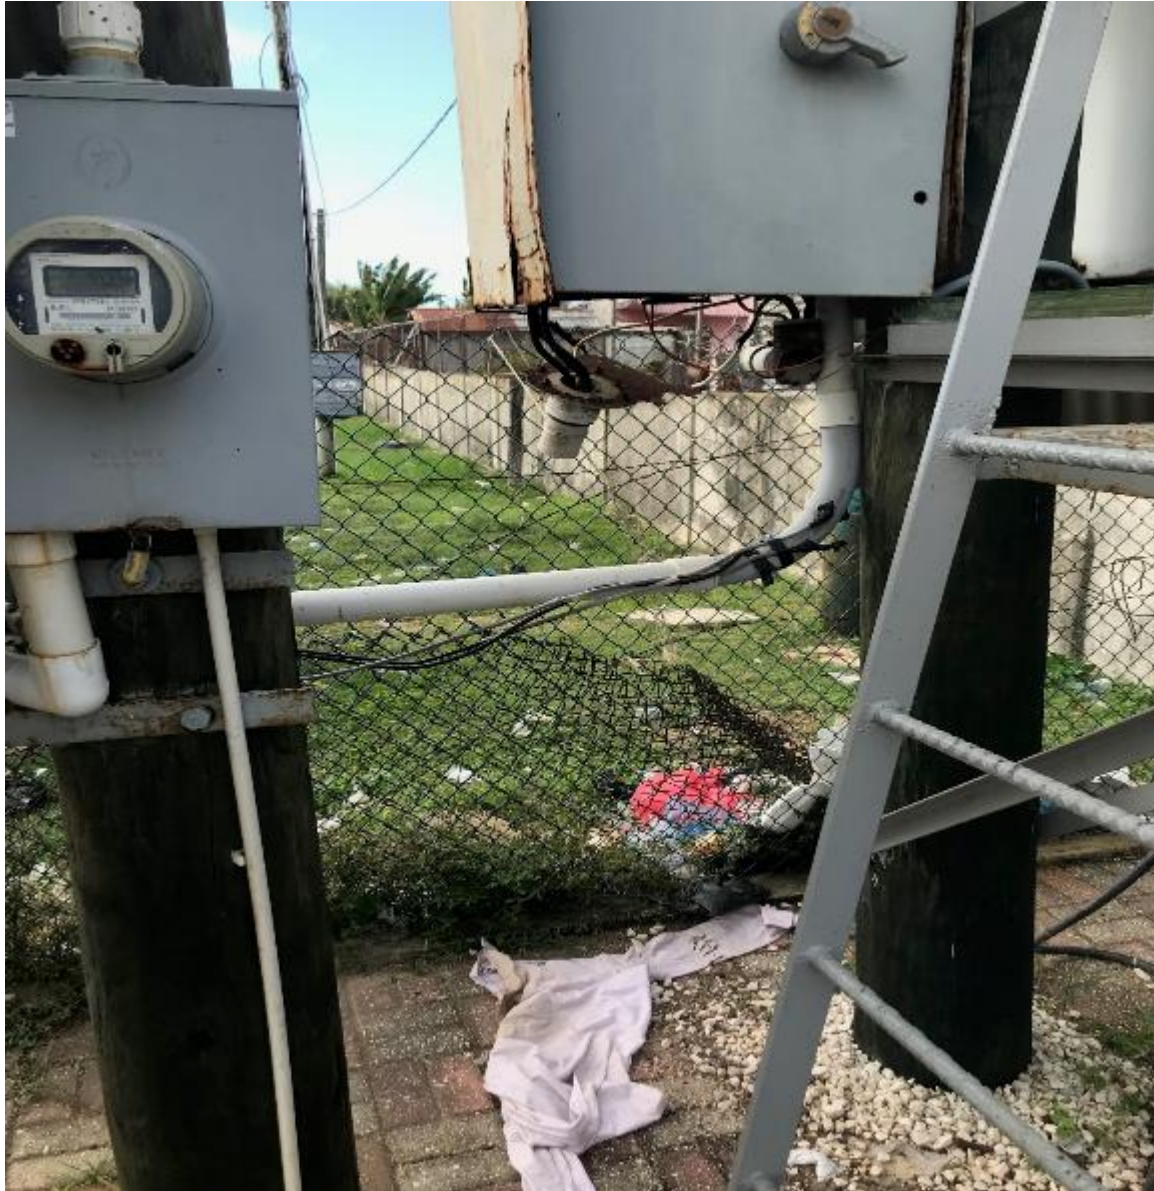
Many of the stations have exposed electrical which are hazards to anyone around the station. We recommend an electrician assess and repair exposed electrical.

Exposed electrical for generator connection at N3.

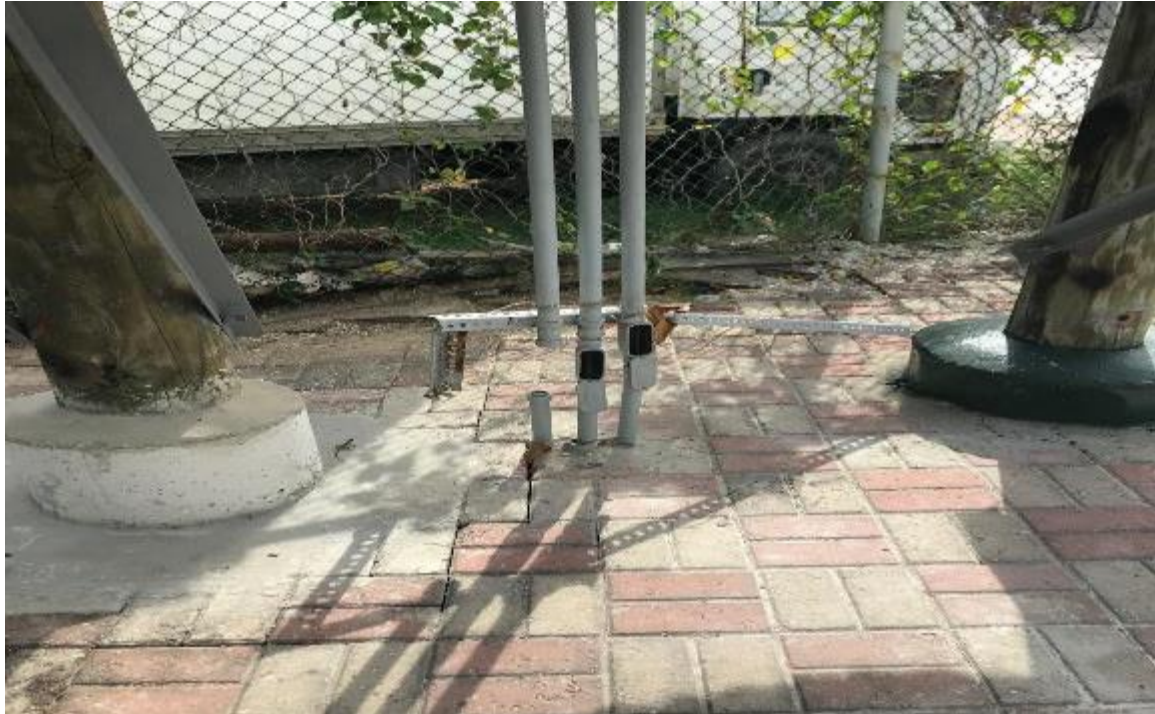
Exposed electrical.

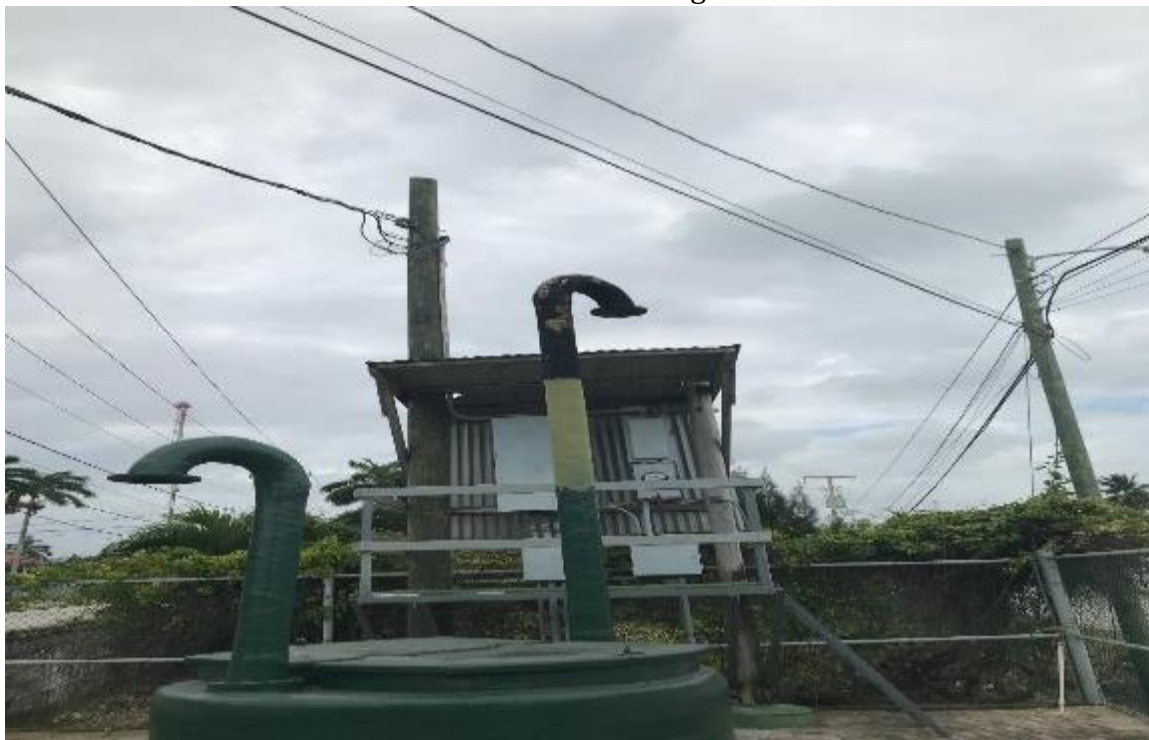
Station N6 – Overhead wires create a hazard for pulling of the pumps.

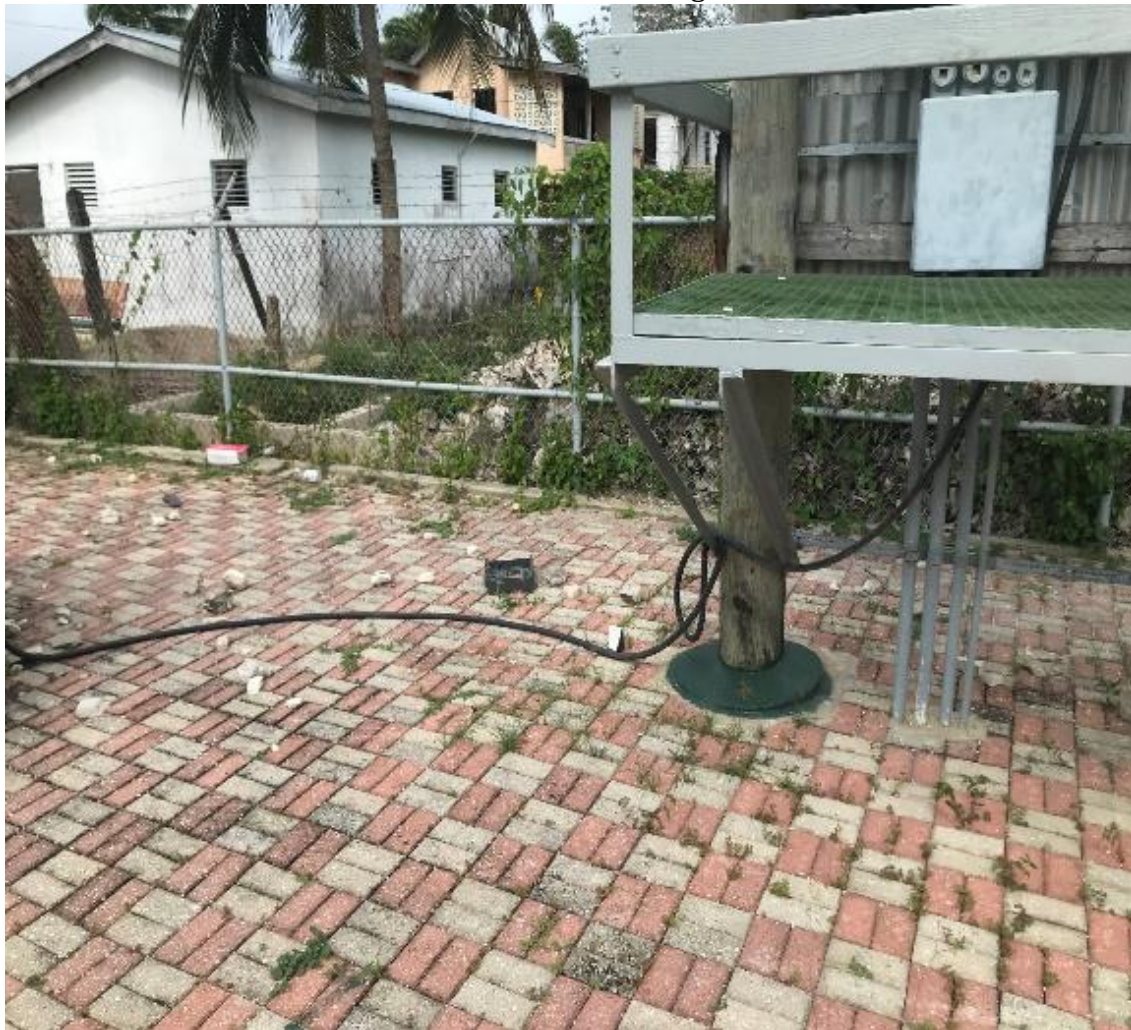
Several stations had pump power cables running out of the hatches and across the ground to the panels. This exposes the cables to the possibility of being damaged. It is recommended these are returned to their conduits for protection. A review with an electrician may allow for pump quick connects to be added to allow for connection and disconnection of the pump at the wet well.

Exposed pump power cable.

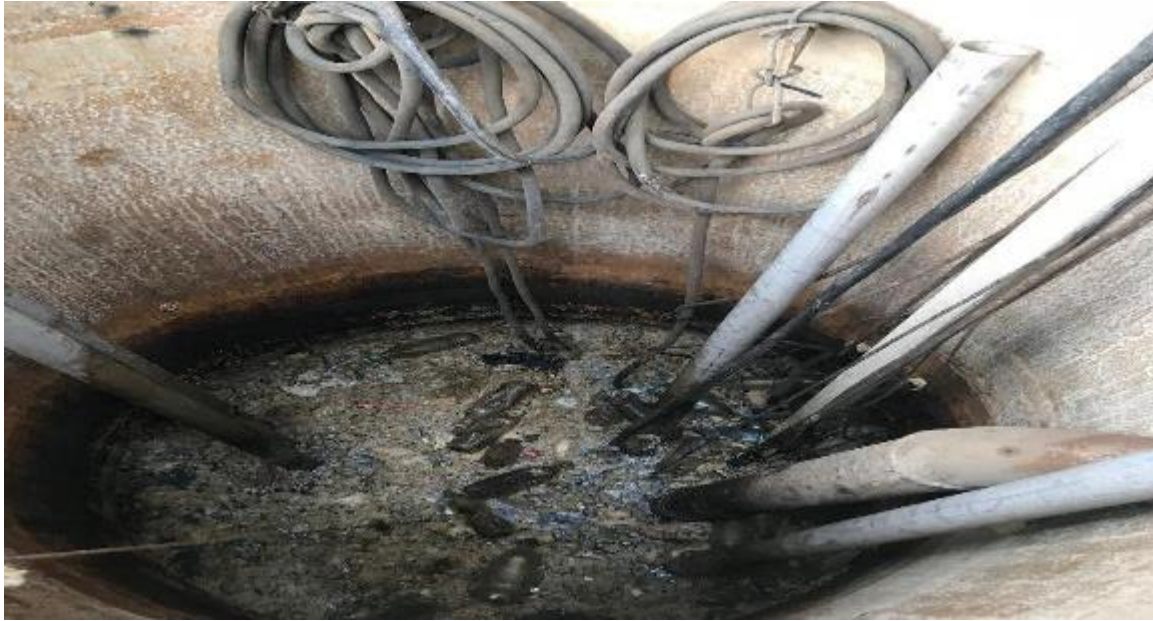
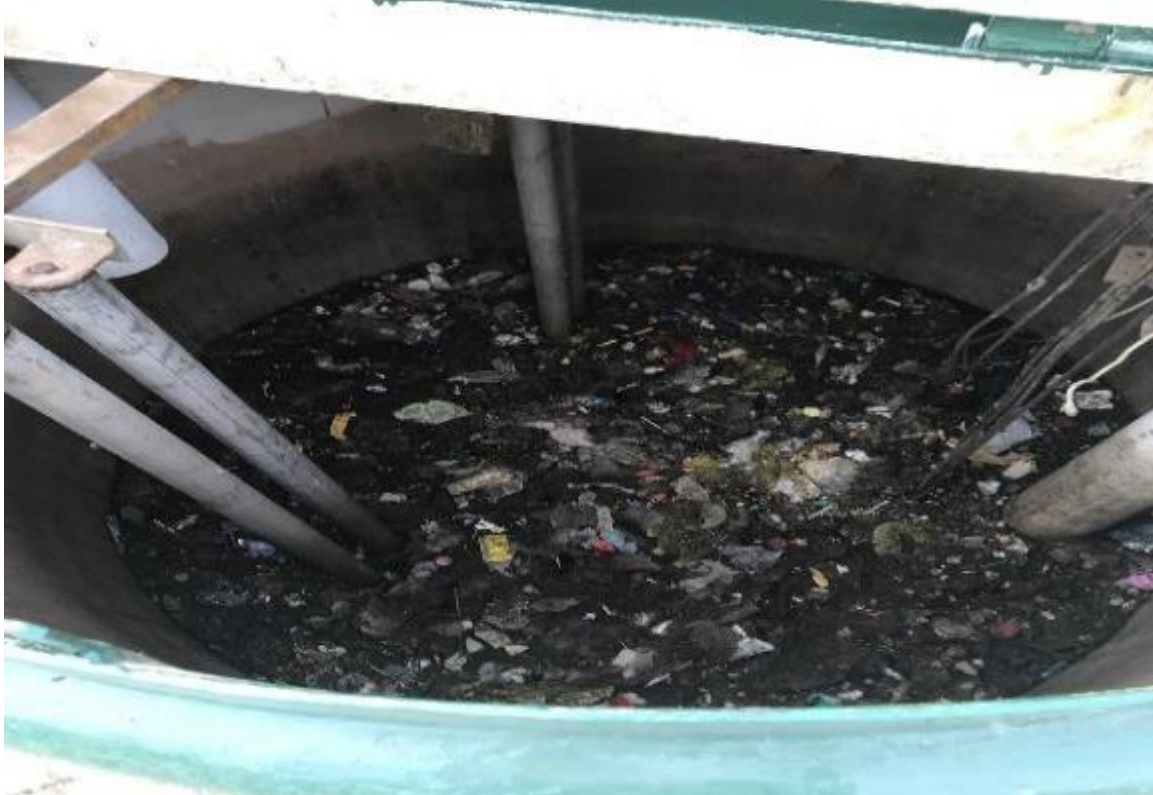
It was observed that no hatches were locked at the stations. The concern is that anyone could open the station and fall in. It also has allowed people to use the station as garbage cans. It's recommended that the hatches be locked at all times.

Note: garbage in the stations.

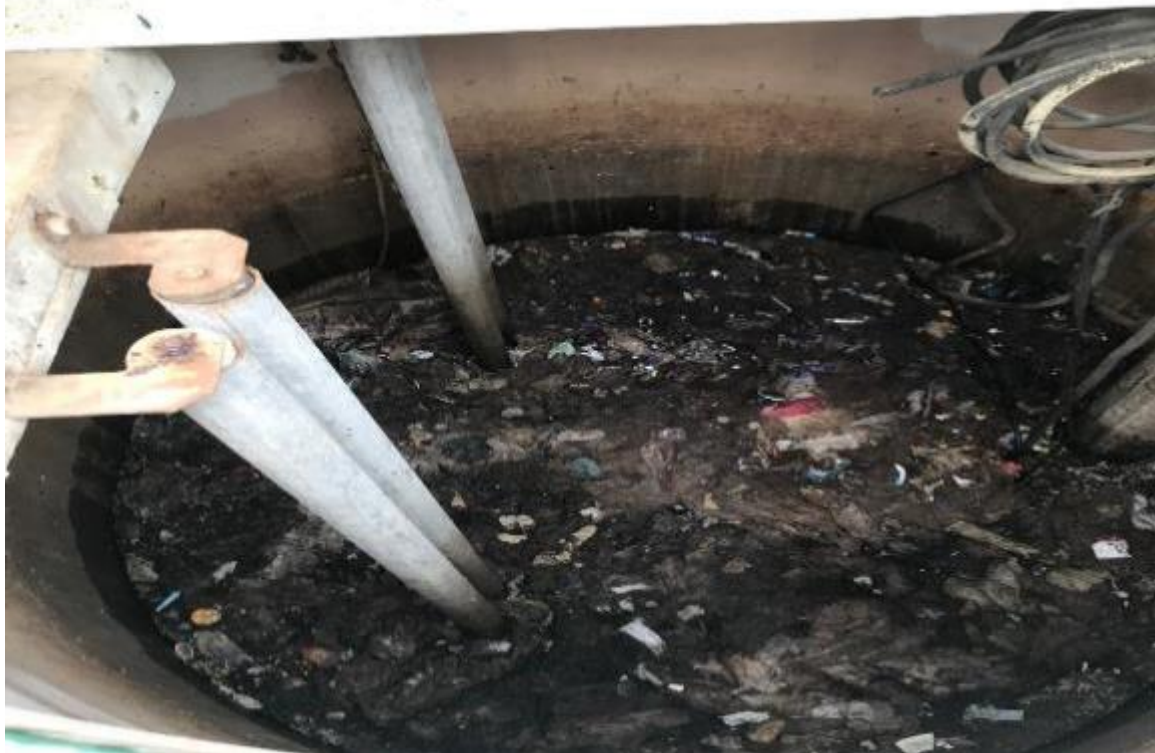
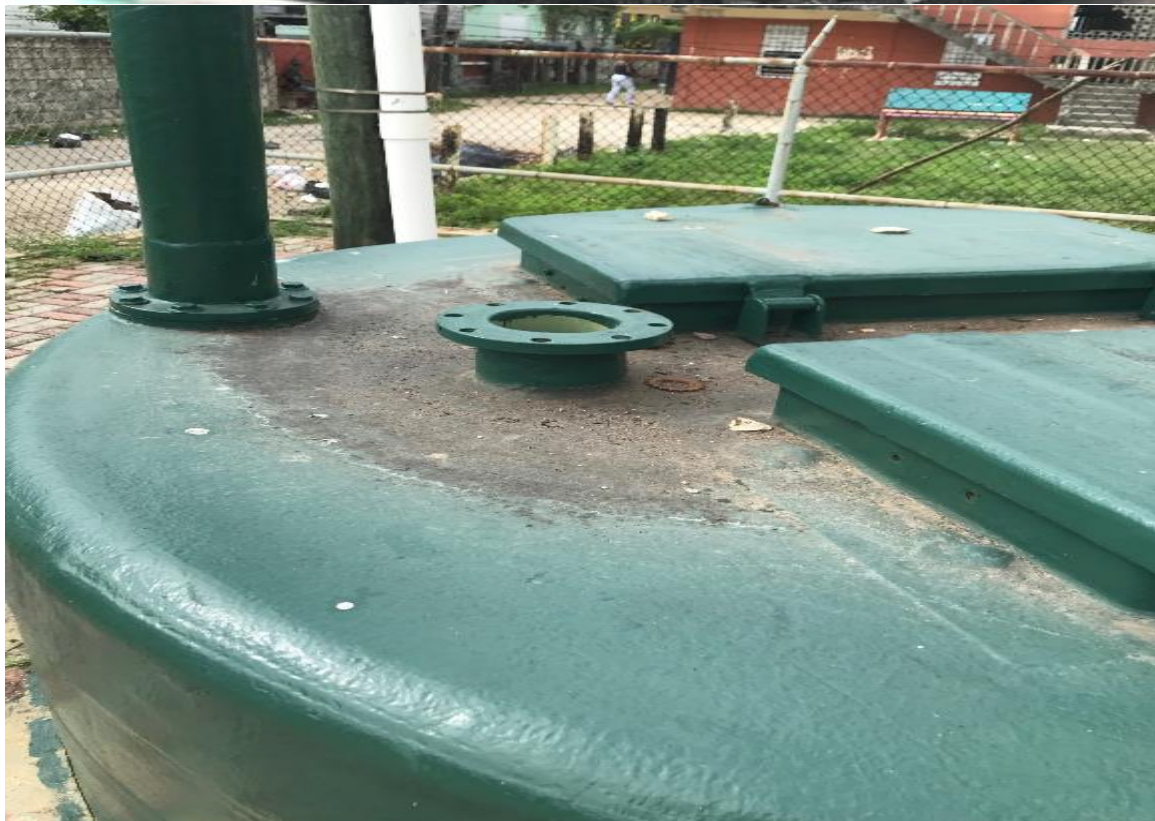
Note: Flange should be sealed to prevent debris entering the system.

An option to assist with maintaining the cleaning of the stations and help keep fats, oils and greases in suspension is a wet well washer. <https://biomaxx.ca/wp-content/uploads/2018/01/EP-1100Series.pdf>

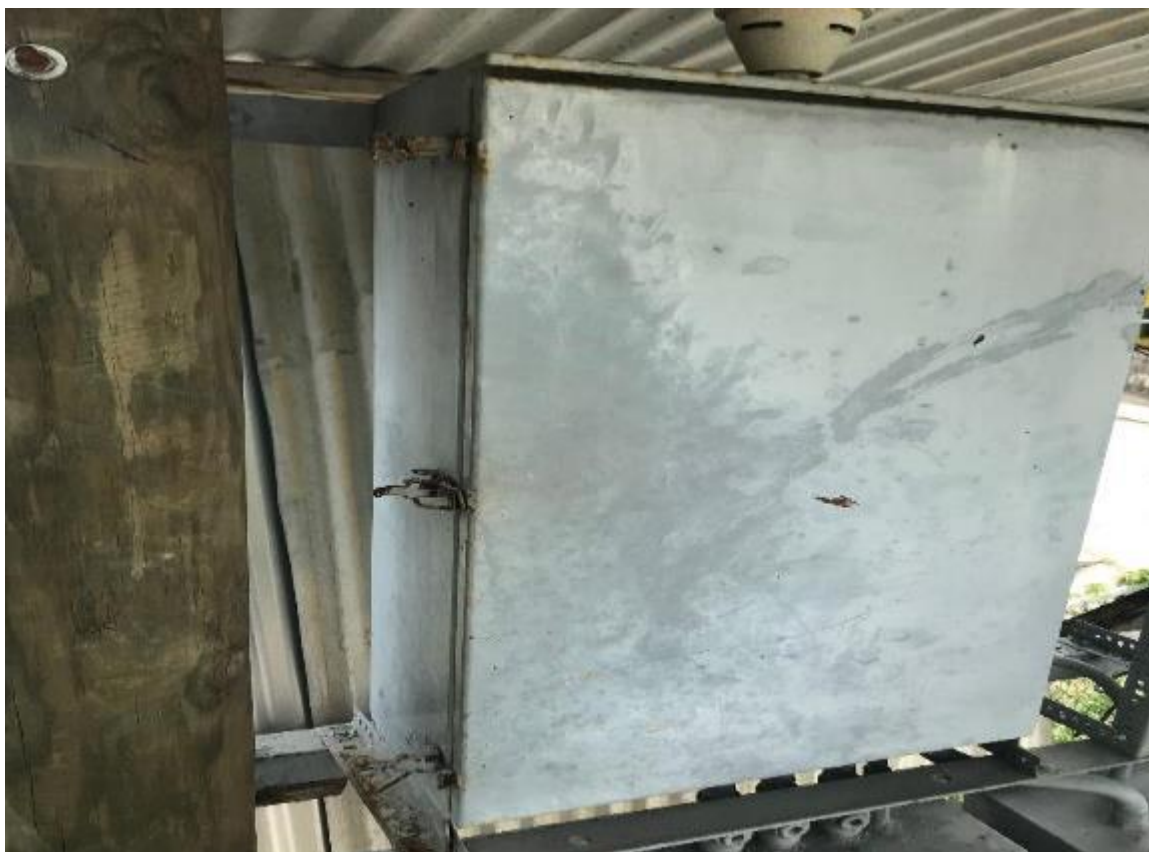
It was noted that control cabinets and main power disconnects were not locked to prevent unauthorized access. Cabinets and disconnects should be locked.

Control Cabinet.

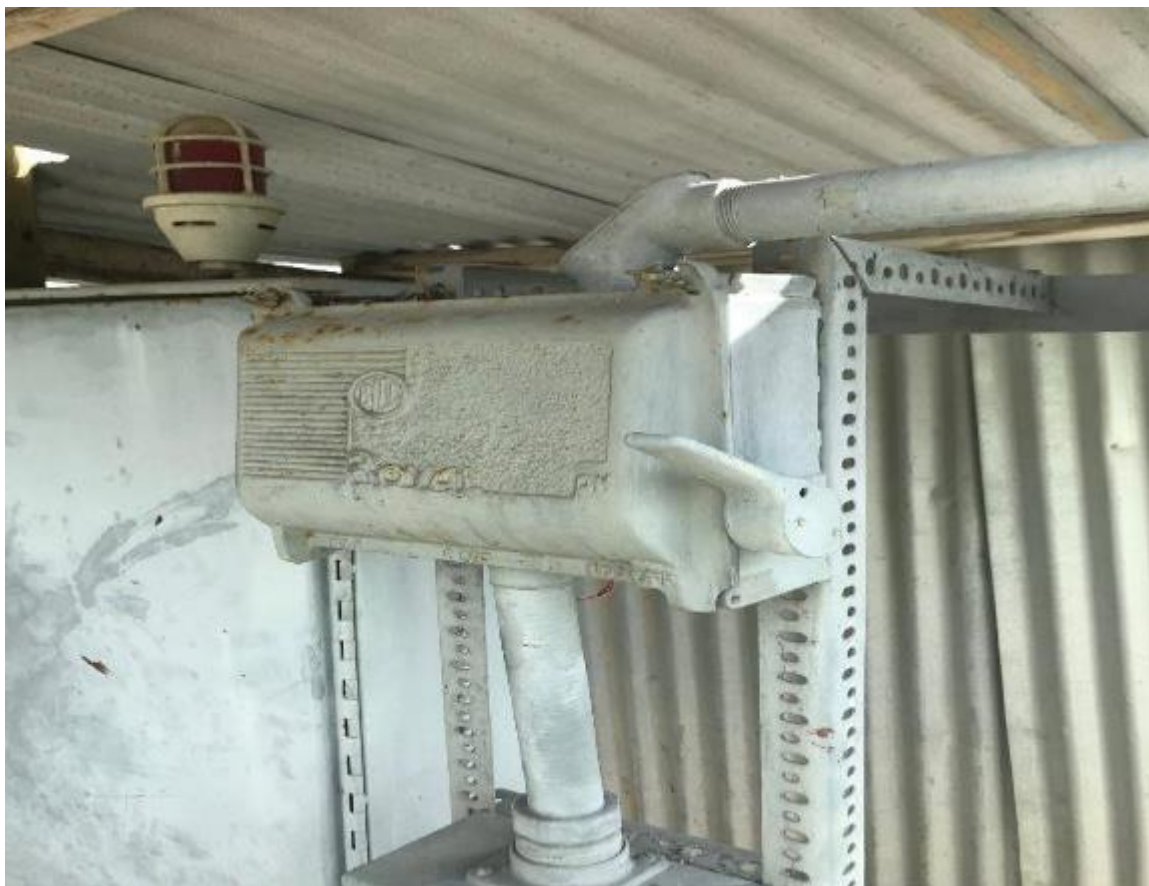
Main Power Disconnect.

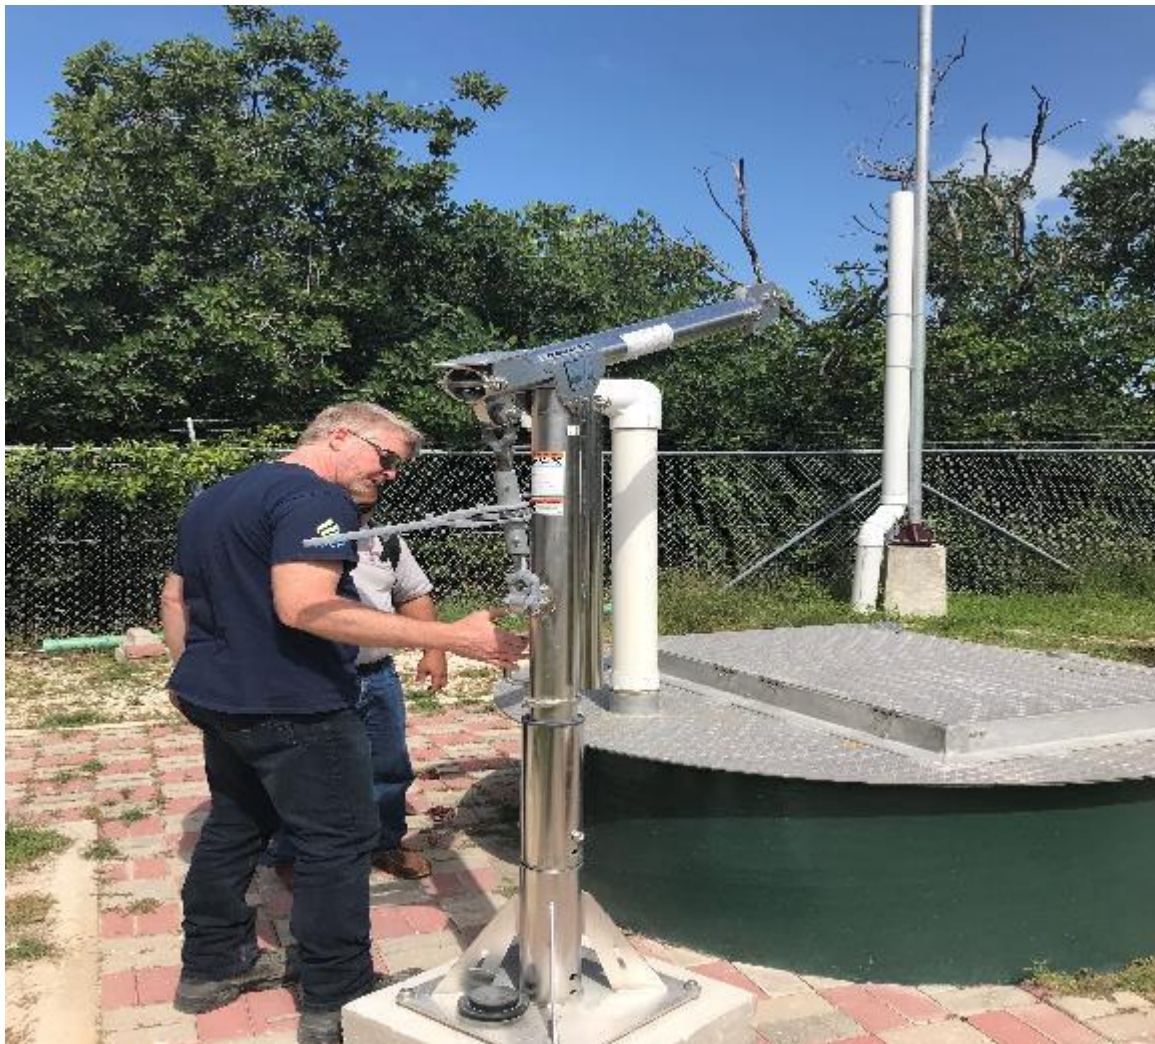
- Backflow prevention required on water supply at all stations to prevent contamination.
- Repair water supply at stations that are leaking and consider moving or extending lines that are accessible to the public through the fencing.
- Constant positive ventilation for all wet wells to reduce buildup of hazardous gases.
- All pump control panels should be locked.
- Inspect and repair all generator connection points at each station.
- Signage on the entry gates should be at every station, clearly marked with BWS contact info and site ID.
- A red curb to indicate no parking in front of each stations compound for ease of access.
- Current height of all wet wells makes set up of Confined space tripod difficult.

A Davit arm system would be the most cost effective. This would be a permeant base socket poured at each site with a removable Davit arm that can be used at each site.

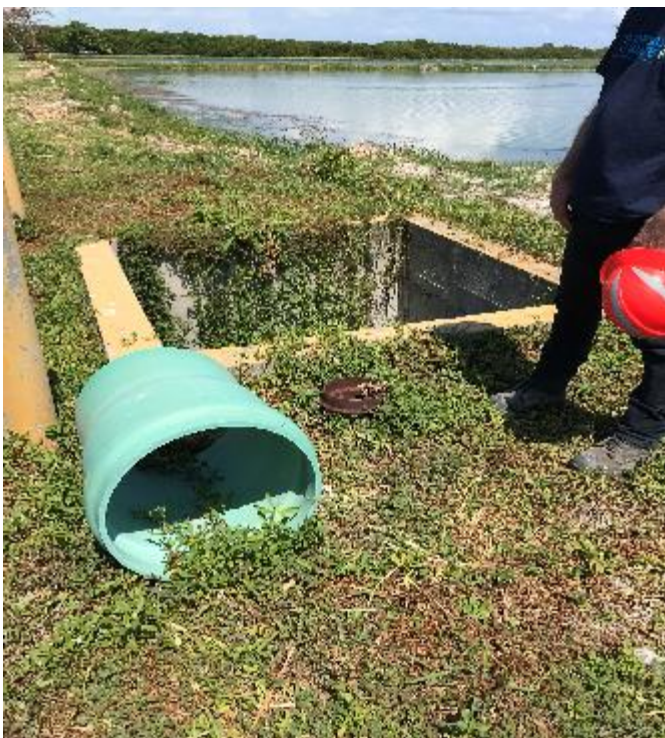
Purpose of valve was unknown, they are at each chamber, current method of lowering pipe to adjust lagoon height is cumbersome and limited.

In order to increase retention time in the lagoons a plastic pipe was used to cover the outlet pipe in the chamber and essentially increase the height of the lagoon before discharging by gravity out the outlet pipe to the polishing lagoon via the chamber. This pipe was one size and appeared difficult for staff to fit onto and remove from the discharge elbow pipe. The chamber would benefit from using stop logs that would be slotted into "U" shaped railing mounted onto the sides of the chamber then 4X4 stop logs stacked into the channel to increase the height in 4-inch increments. If a bolt is run into the logs on both sides it would act as an anchor and handle for staff to use for ease of removal. Examples can be provided if interested.

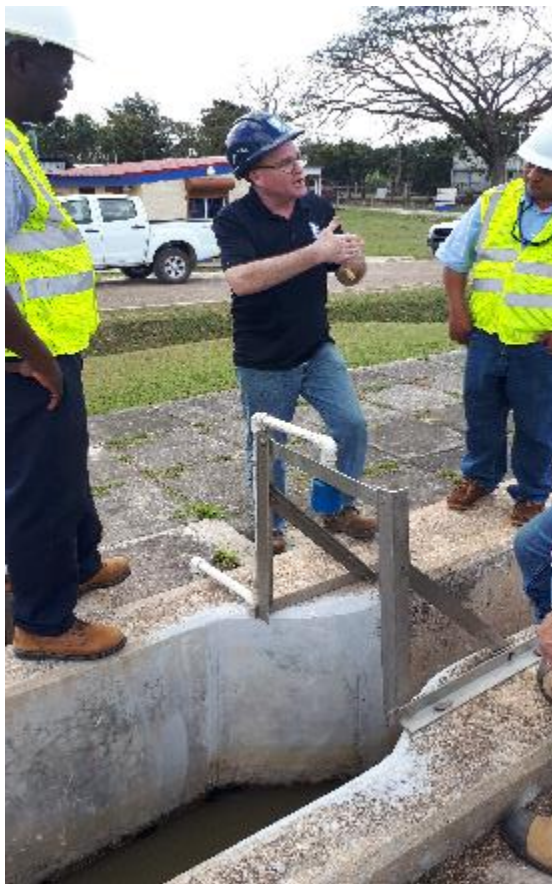
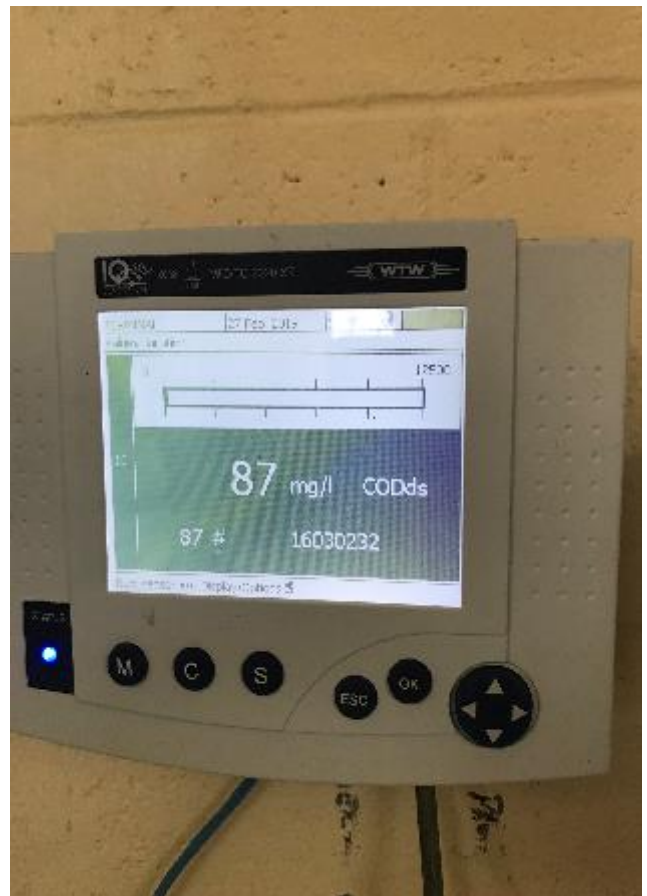
Numerous examples of instrumentation that was out of calibration, improperly mounted or giving alarm signals were observed. In order for staff to make competent decisions at facilities any existing instrumentation must be cleaned, maintained, calibrated and verified for proper installation.

Flow meter and on-line analyzer require calibration at Belmopan

An inventory of all instrumentation should be taken then, at a minimum, annual calibration should occur and be documented and displayed on the instrument with a ticker so staff know they are taking reliable readings. Any major deviations must be

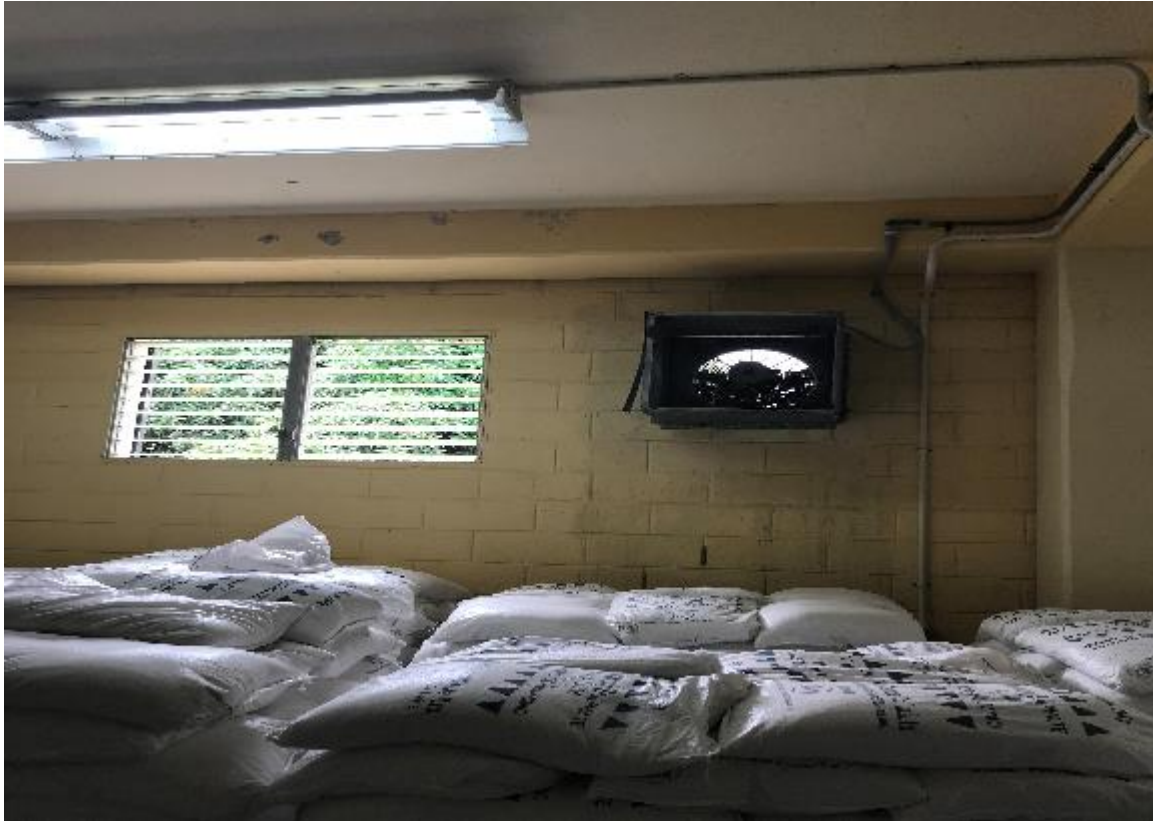
**Two out of six fans have no blades and are not functioning**

The room at Doublerun had six evenly spaced ventilation fans with three on each side of the building supplemented by windows that could open. Only the windows were being used for ventilation. Upon observation, two of the fans on one side were lacking fan blades and thus not functional. Of the remaining 4 fans, two were blowing directly at each other thus negating the ventilation capability. The remaining two fans were blowing out from the room. All six fans should be restored to working condition, configured to have the three fans on the wall where chemical is stored blowing outward and the three fans on the opposite wall blowing fresh air into the building. In this set up fresh air would be carried into the building and blow across the tanks and stored chemical and out the opposite site assisted by the outward blowing fans. This would move potentially corrosive gas away from the pumps, electrical panels and piping.

Possibilities exist for walling off the chemical tanks using plastic curtains that would block fumes but allow complete access to the mixing motors. If this option was implemented thought should be given to a roof exhaust system over the curtained off tanks.

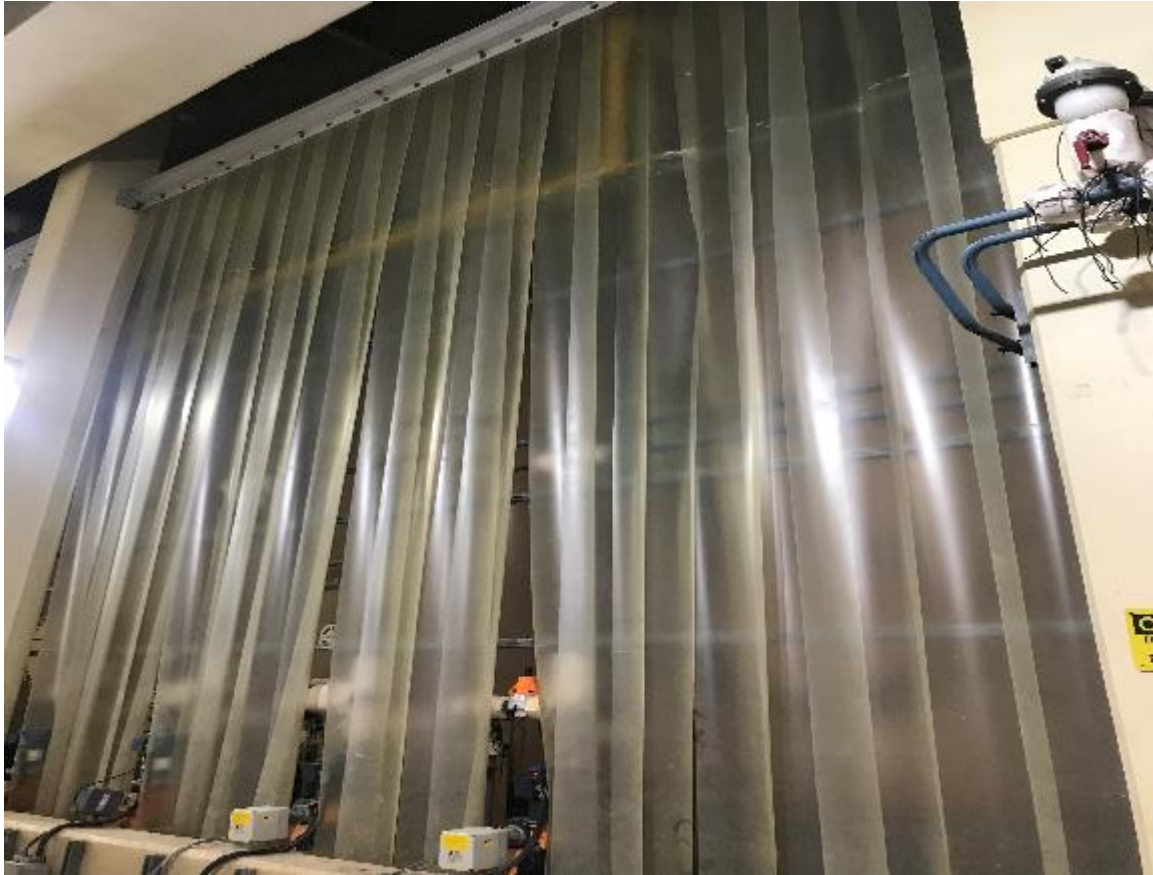
Chemical curtains to isolate fumes and mists while allowing complete access

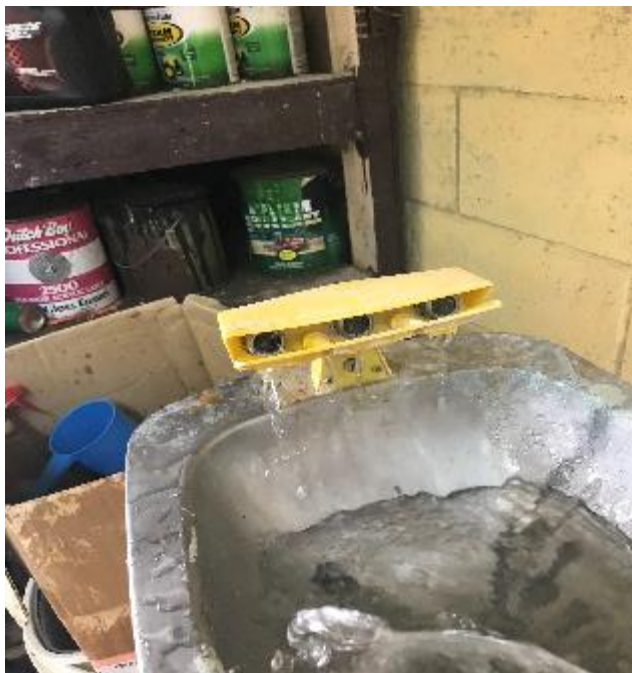
Some eyewash/shower stations were not properly functioning or blocked from access. A routine monthly check should be performed on these and all other pertinent safety equipment. This check should involve a form that is signed beside the equipment similar to a fire extinguisher check to let staff know the units are safe and operational. Staff should be trained on the requirements of the equipment and what to do when a unit is found not working.

Nonfunctioning eyewash doublerun

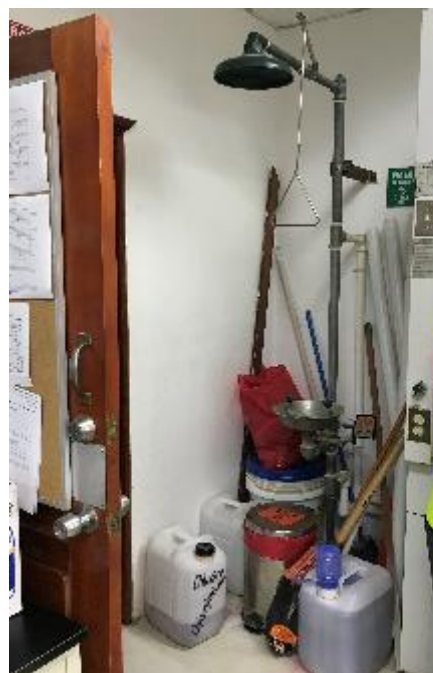
eyewash blocked in lab area

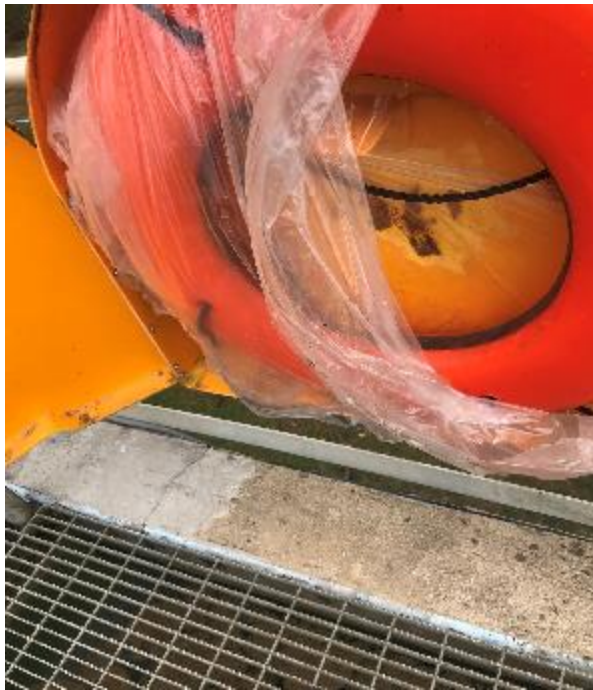
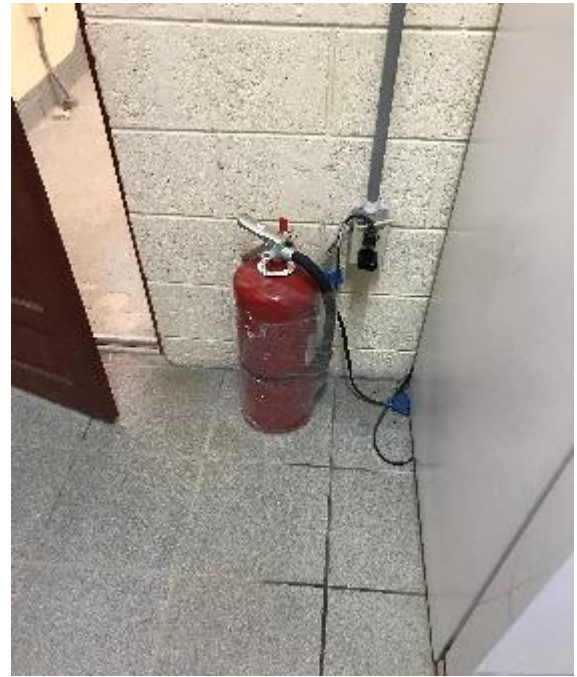
Some equipment such as very outdated life jackets well past their expiry date were still being used. Other equipment was new but left in the original packaging which would limit its use in the time of an emergency. All equipment would benefit from a monthly check as suggested above.

Ensure equipment is ready to use and original packaging removed

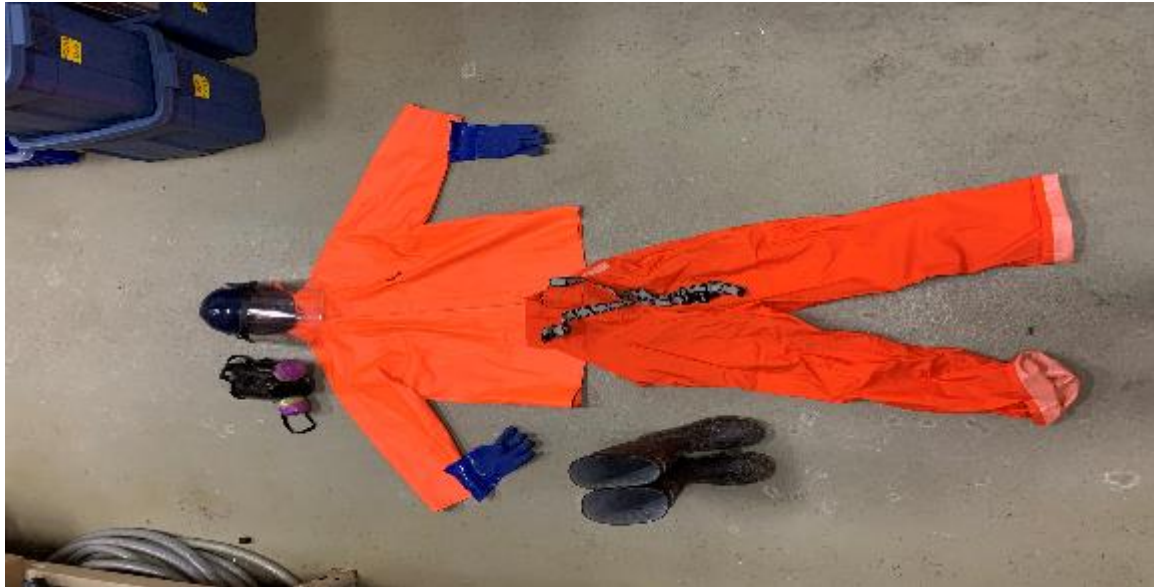
One complete set of spare PPE for each chemical mixing room

Although individual staff are issued appropriate PPE it would be beneficial to have an additional set in key areas, like the chemical mixing areas, so staff can quickly utilize if they did not have their own personal set readily available. Once provided two access points to PPE there is no excuse for staff not to be wearing it.

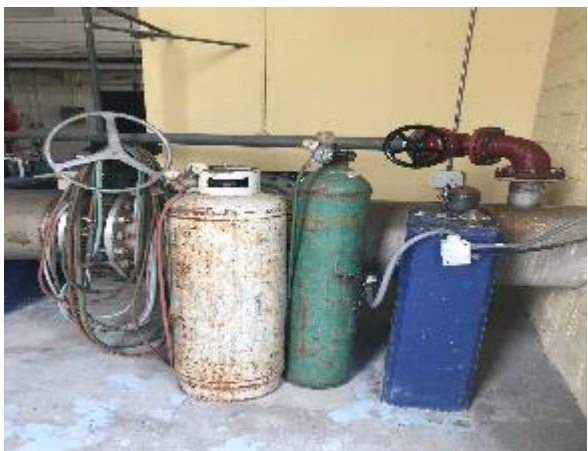
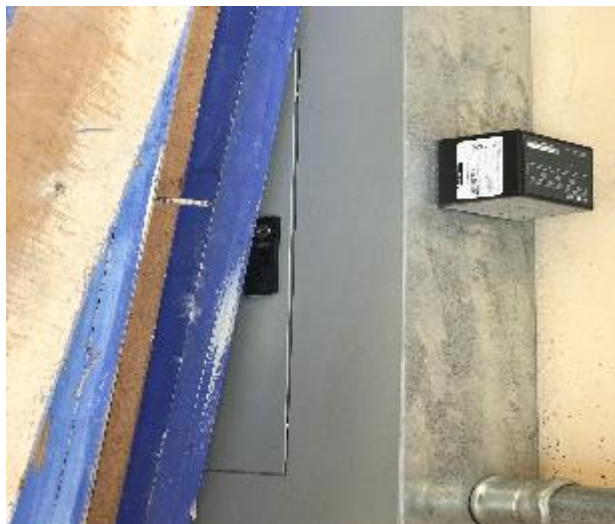
Storage of chemicals, gas cylinders and other items near electrical panels. Several examples were observed where housekeeping issues have created a hazard for preventing access to safety equipment such as eye washes or for limiting access to electrical panels due to items stored against them. Although storage can sometimes be limited, a different solution should be found. Staff need unimpeded access to work and to safety equipment.

Chain compressed cylinders in place - Do not block electrical panels or controls
