Belize Water Services Assignment

ASSIGNMENT WITH BELIZE WATER SERVICES LIMITED REPORT

FEBRUARY 16 – MARCH 4, 2019

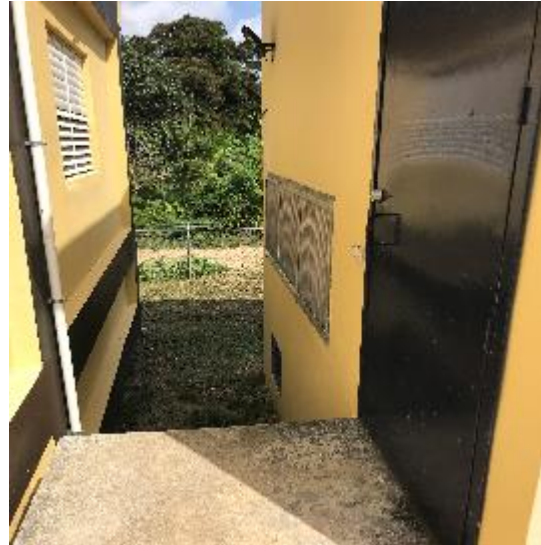
Area has one story drop, chain area

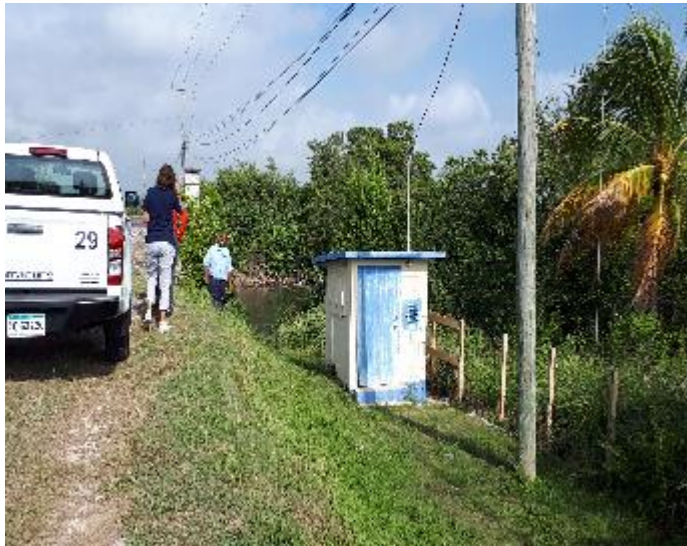
Be aware of path required to access areas for work and during rainy season

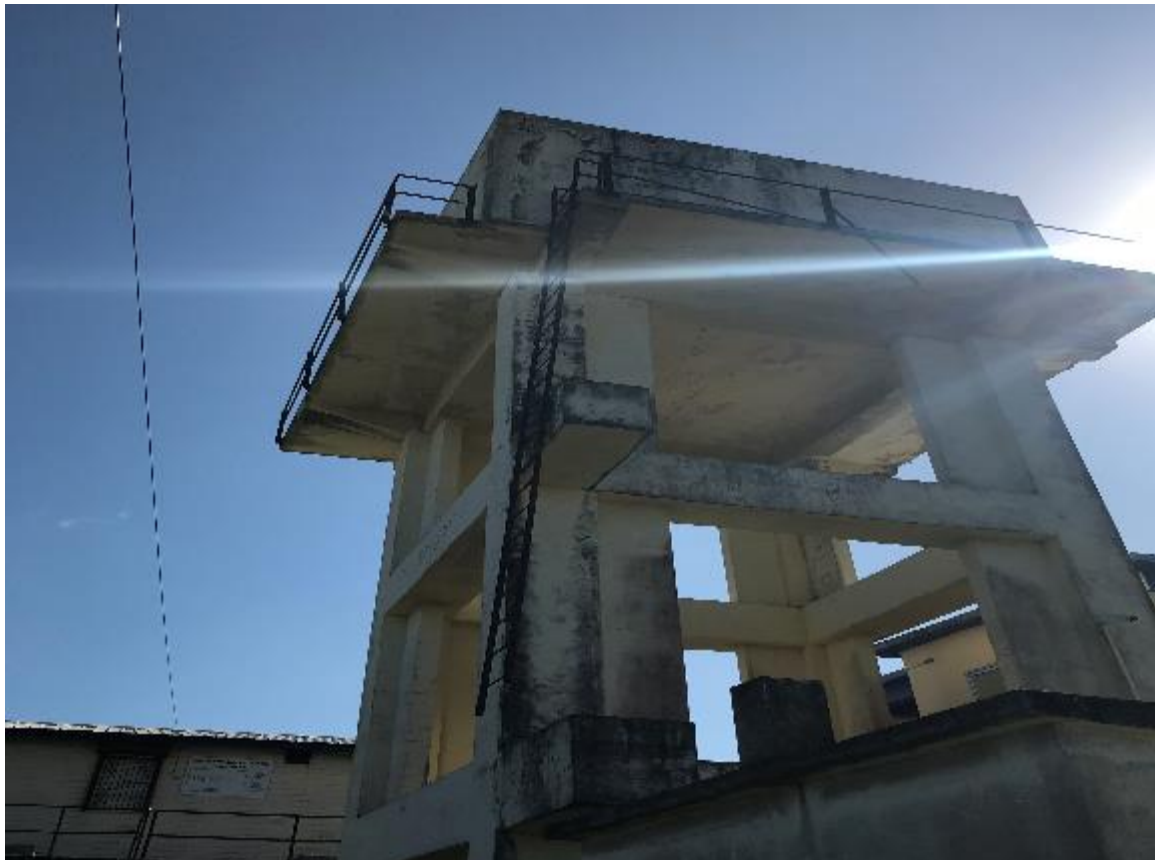
This location requires immediate remediation. The metal ladder work and guardrails on the upper portion of the facility have completely eroded to the point of no longer being functional. They are starting to rot out to the point of becoming dangerous with overhead threats during wind events for staff or equipment below.

This facility was also the only facility in the public eye that appear to be unkept on its exterior. Being centrally located on the major roadway in Placencia, and known to be a BWS building, this can potentially tarnish the reputation of the company in the eyes of customers. Perhaps when scaffolding or other measures such as a lift bucket are used to correct the failed railings the facility could be painted or at least power washed.

Scaffolding should be taken from the Doublerun plant or another source and constructed upon the roof of the stand-by power building to allow access to the catwalk at the upper reservoir tank. Having securely tied off a worker, the worker should torch or cut out all damaged and destroyed metal railings. A company will be required to remove the damaged main ladder and safety restore these features.

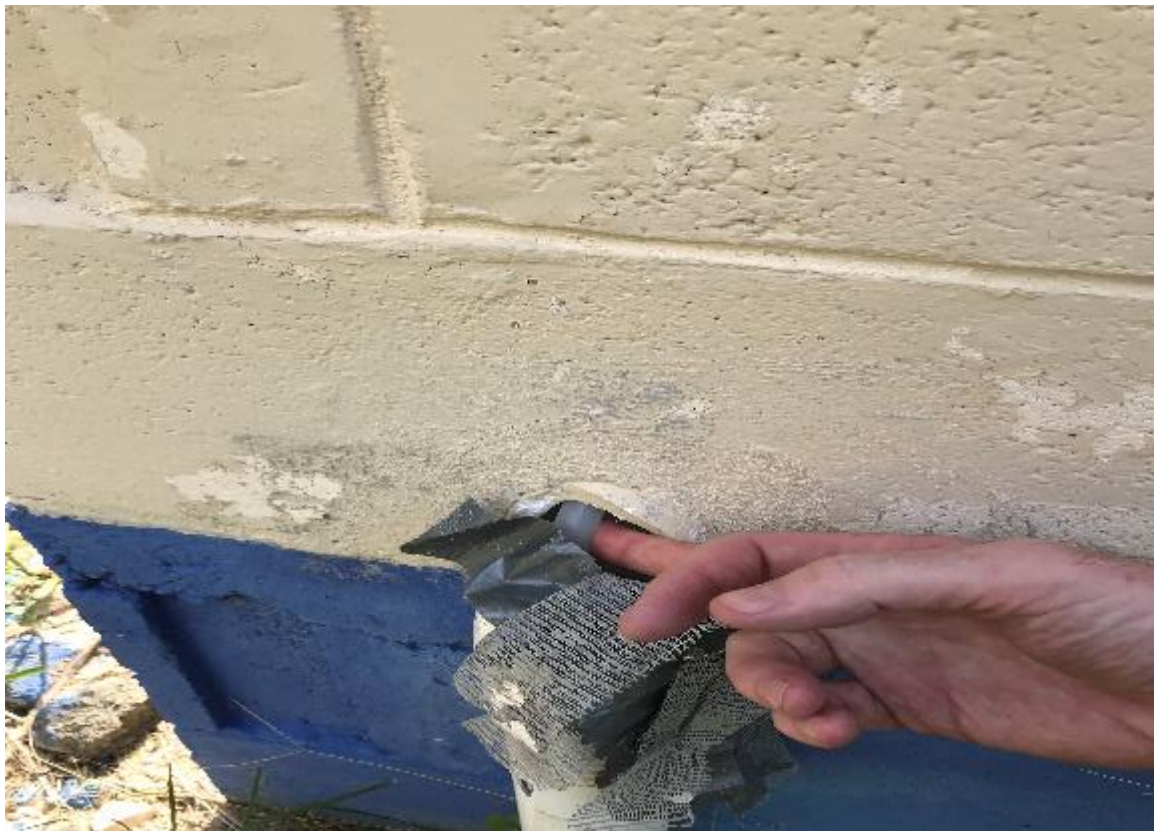
The mile six booster station and chemical addition point. This facility appeared to have no alarms on the door. There was evidence of previous tampering by neighbors to acquire electrical power for their activities, so it is vulnerable. The pipe leading to the injection point for chlorine was exposed and easily could be cut or tampered with. This pipe needs to be re-established and protected. It also needs to be accessible as staff indicated the buildup from the Alum needs to be rodded out on occasion. We suggest a quick connect Tee be placed at this location to allow staff to shut off the flow, disconnect either the feed site of the pipe or the side leading to the injection point for cleaning.

Chlorine injection line exposed at back of building

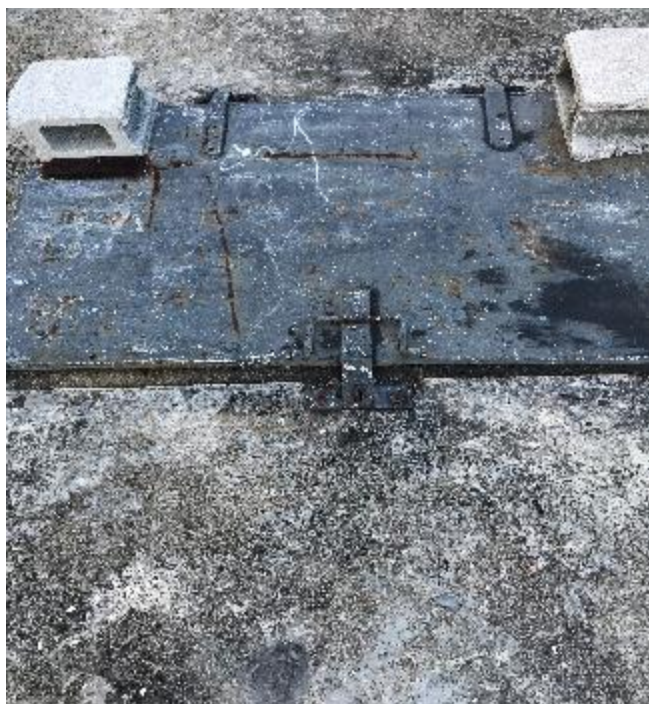
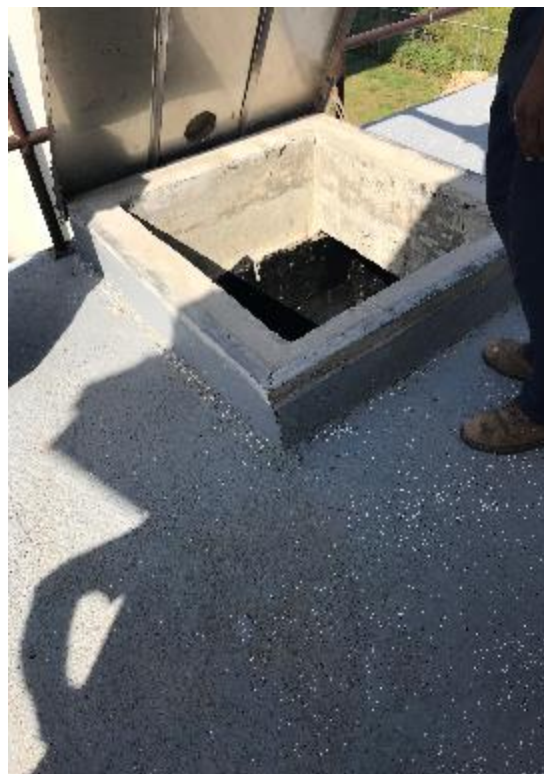
Debris or liquid can enter

Properly guarded against objects

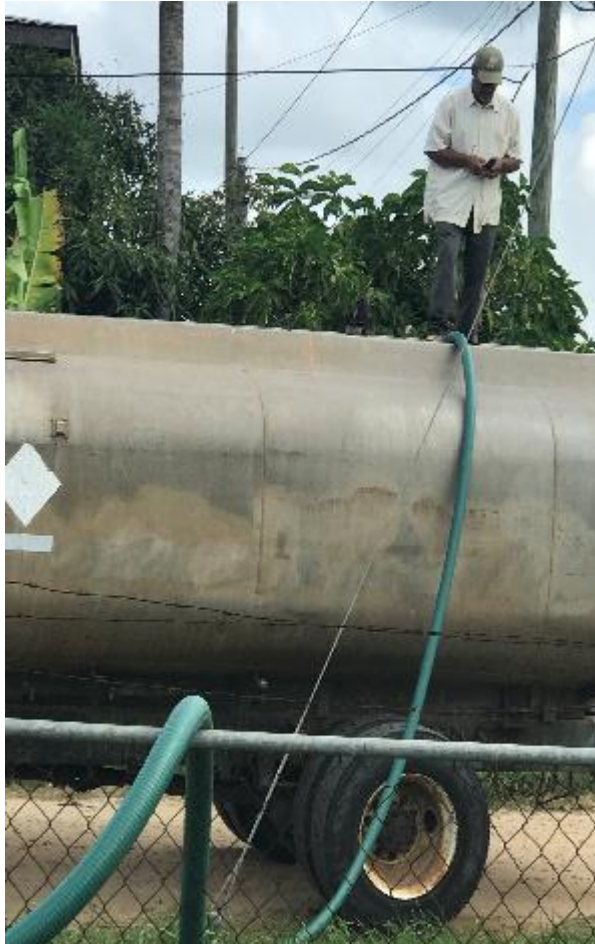
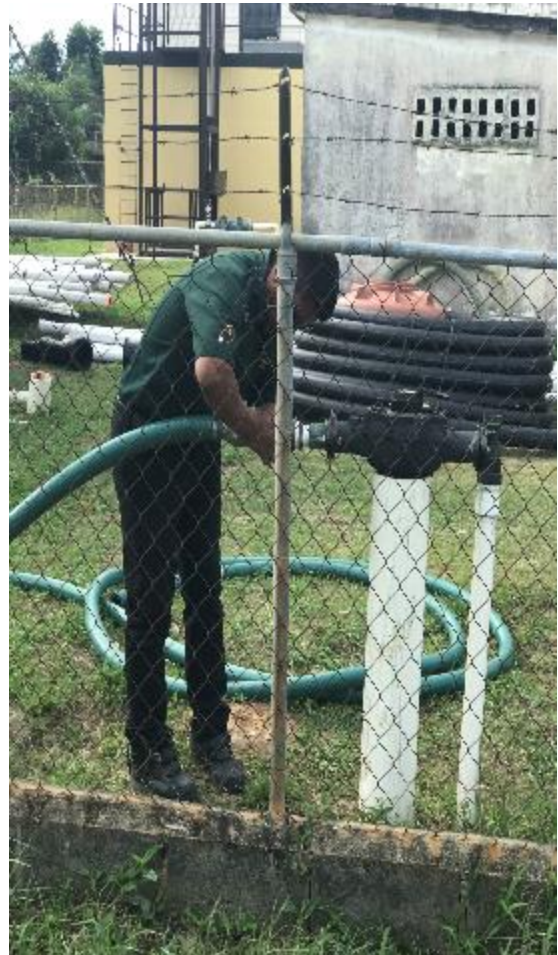
If the level in the truck gets higher than the reservoir at times of high demand it could back syphon.

The water treatment facilities have a connection that is monitored by the guard for filling water trucks or other vessels. These lines should have a backflow prevention device to protect the water in the reservoir in the event of backpressure in the line to prevent any foreign material from the trucks getting into the system.

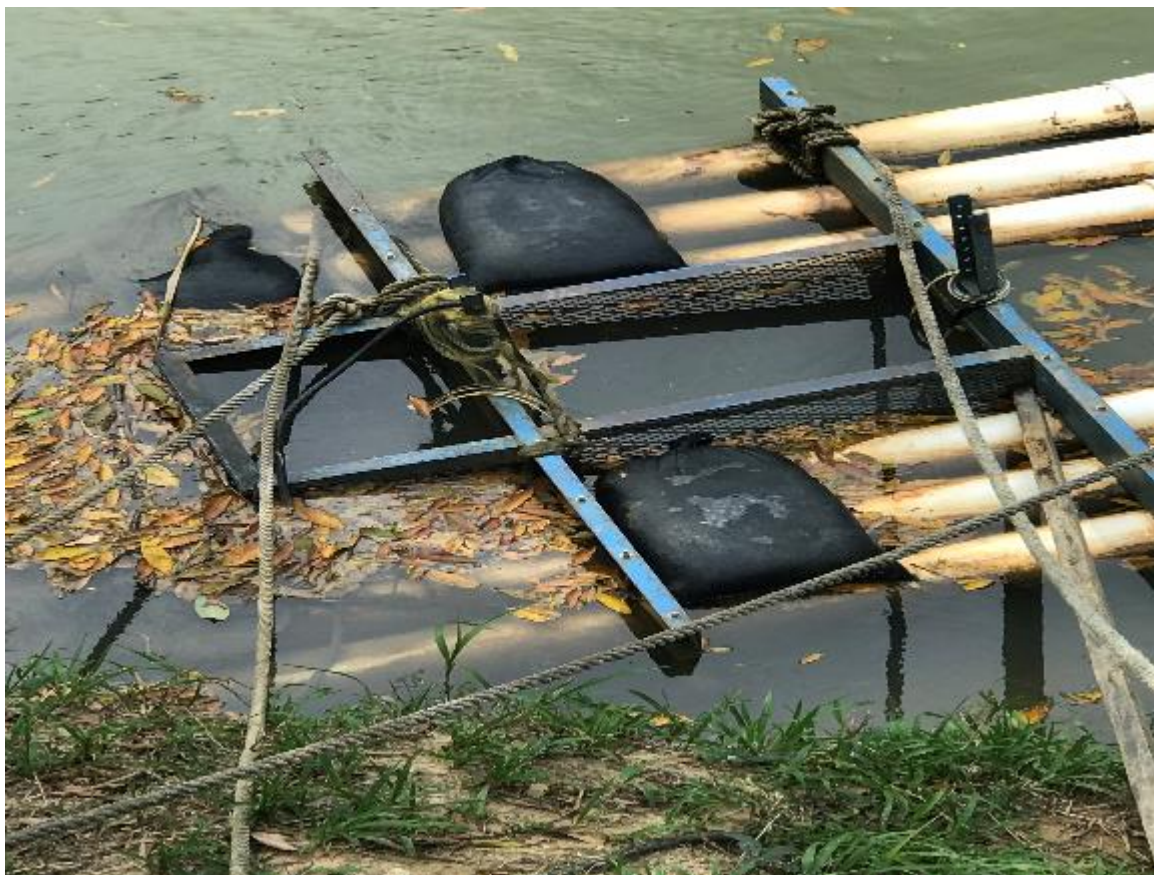
The stone covering over the intake at Belmapan should be fixed to prevent debris and mud from freely entering into the channel. Also procedures should be developed for the safe delivery of fuel to Belmapan as the diesel unit is uphill from the intake and any spill will travel to the river in the area of the intake.

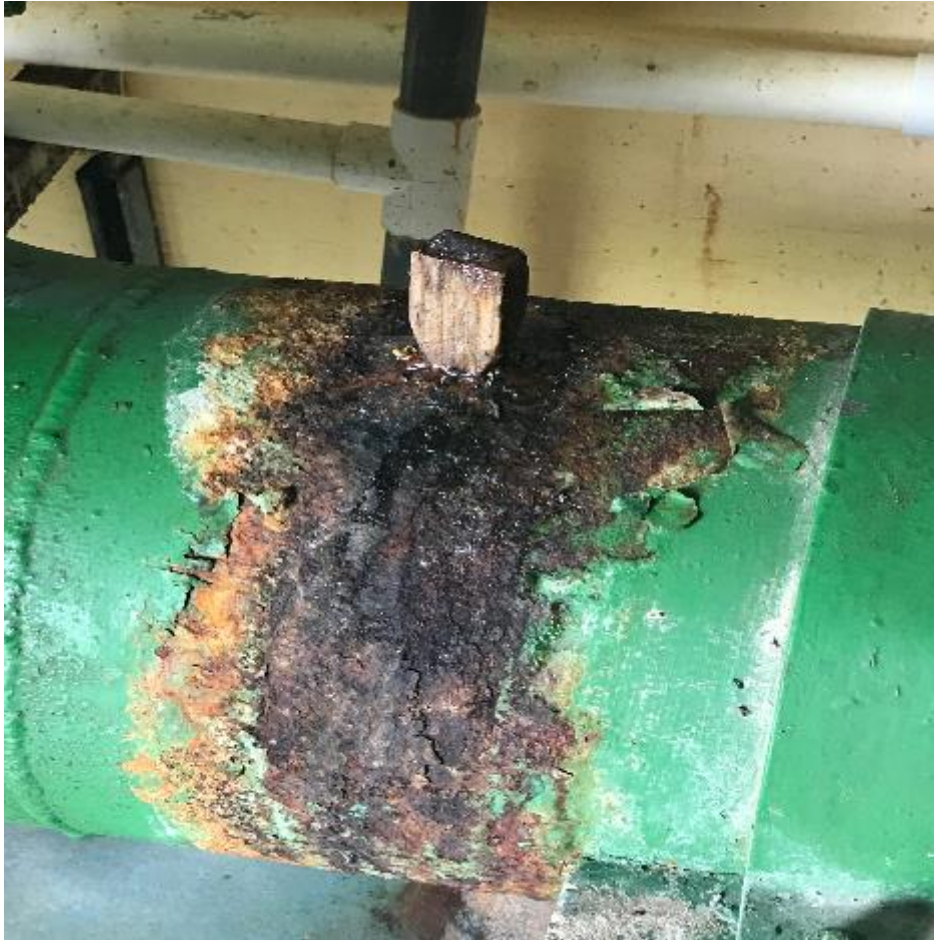
At the Doublerun facility the main feed is scheduled for replacement however there is currently a wooden stake being used to plug a leak in the pipe. This should be reinforced with a saddle or more permanent solution until the final replacement of the entire pipe occurs.

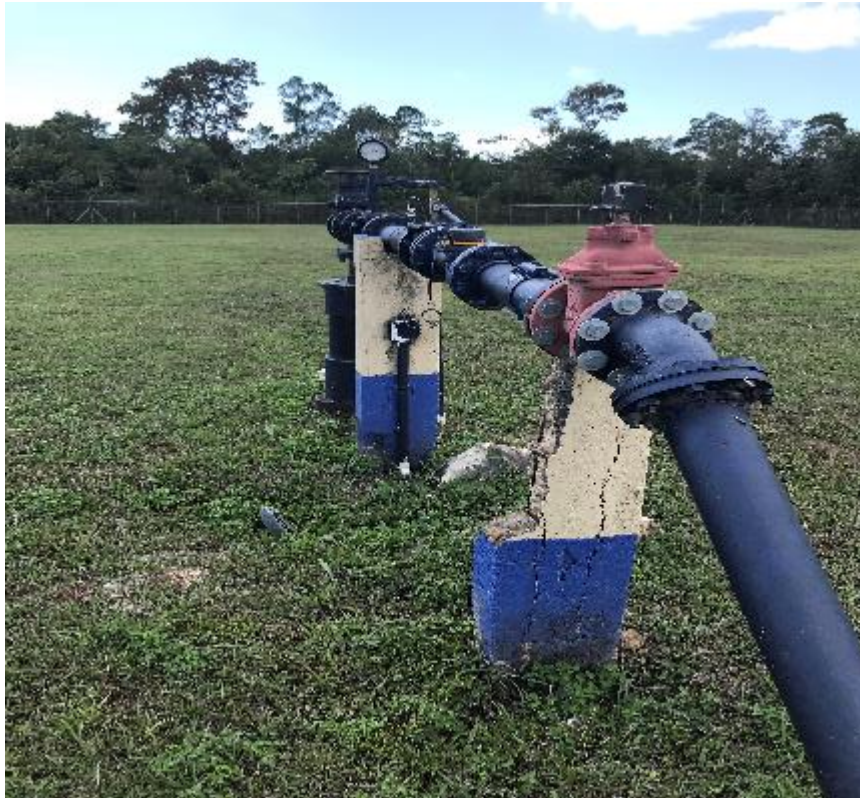
Deterioration of support will lead to critical failure at wells near gravel pit

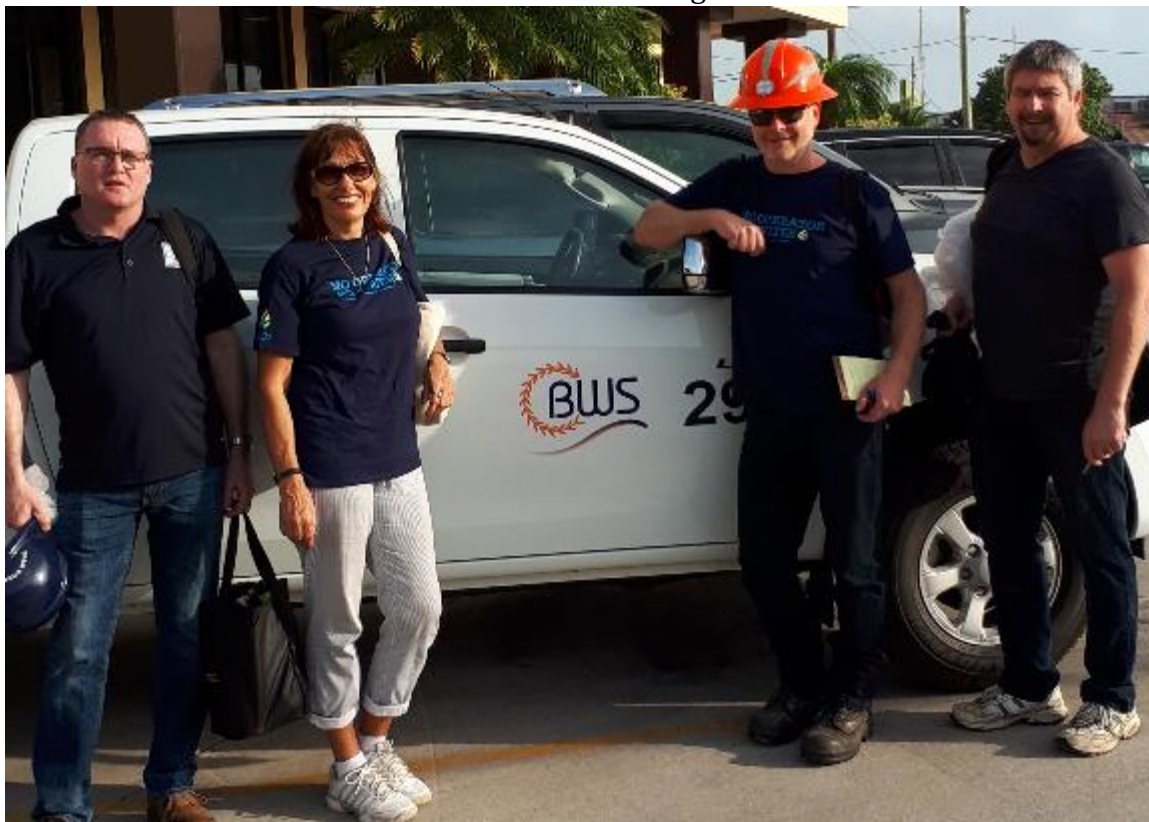
Modern well-maintained fleet

The fleet at BWS is modern, reliable and well maintained. However, it would greatly benefit from a vacuum truck or similar capable device. This would ensure sewage pumping stations could easily be maintained and assist in construction activities. Although a costly investment, senior staff should investigate funding opportunities for such a piece of equipment. Trucks could be modified with storage options to allow a greater variety of equipment to be readily available to crews.

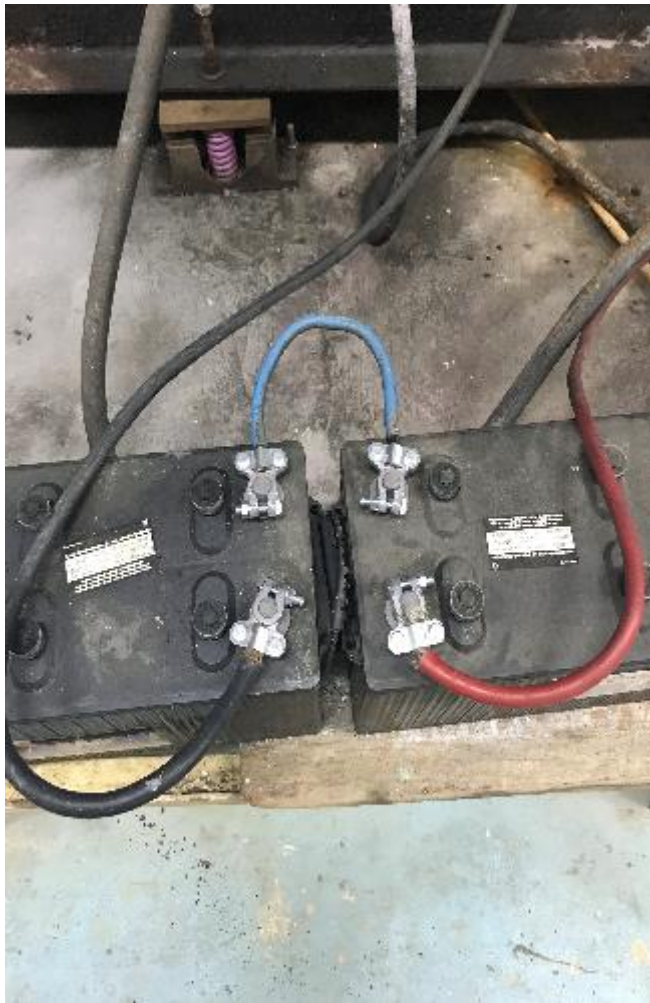
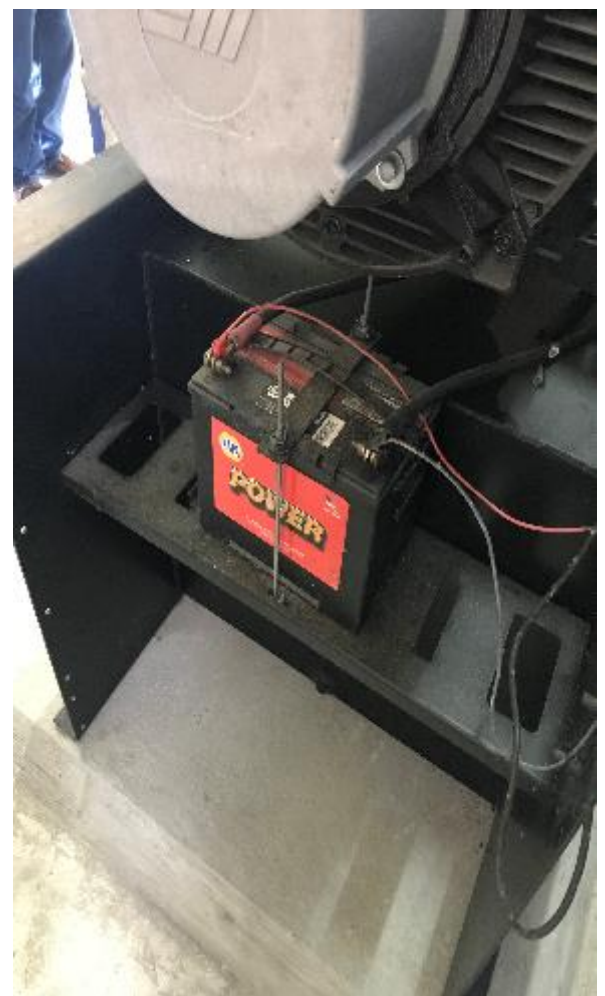
Properly sized batteries but requires protection Small single battery

Due to budgeting restraints one cannot simply modernize all of the facilities. However, smaller steps such as consistent battery size and configuration can be achieved. Also for areas with questionable standby power, a plan should be in place. Battery terminals should have a small rubber mat across the top of them so if a tool is dropped it does not make contact and arc.

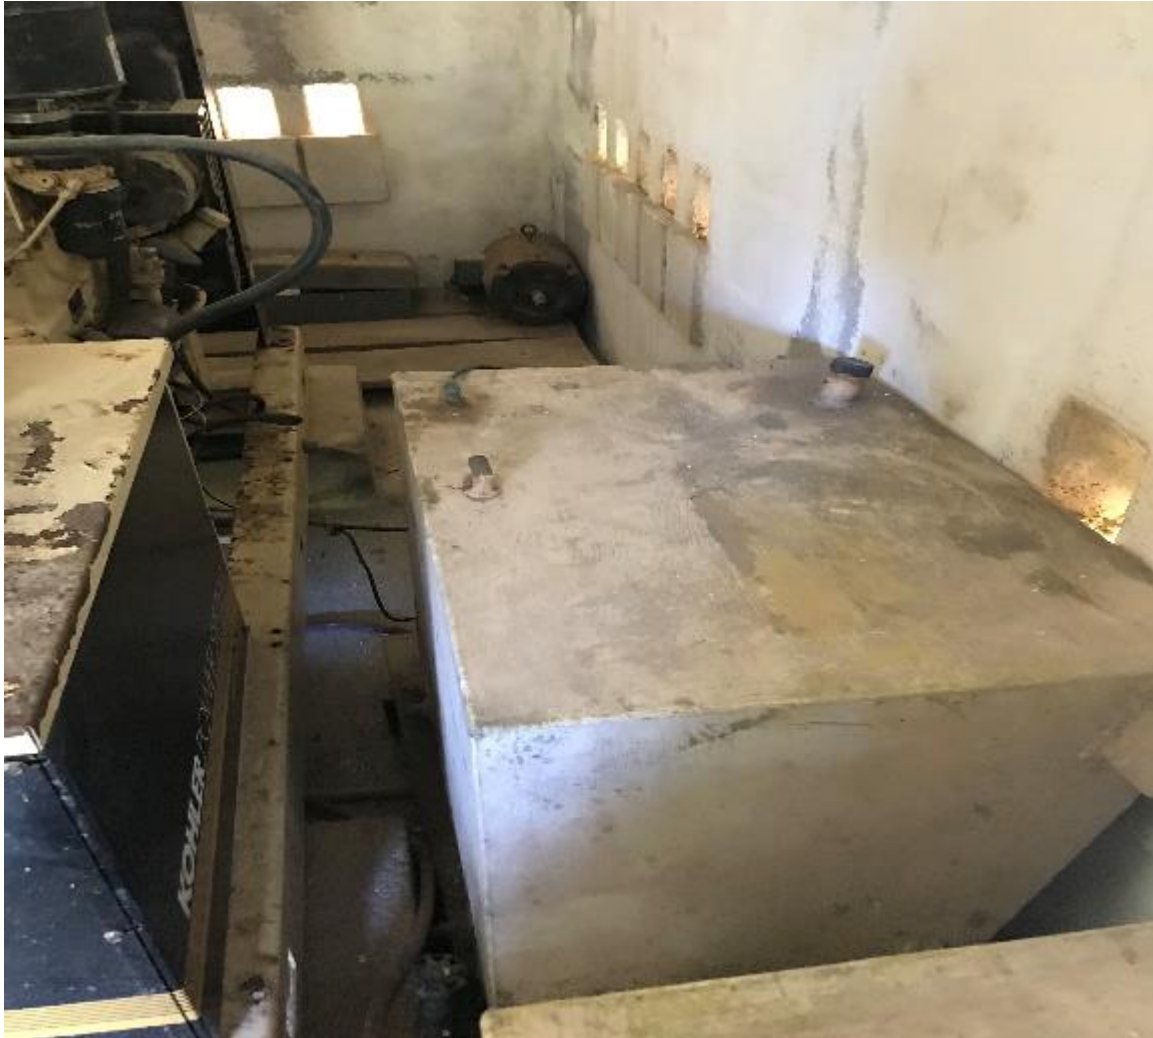
Old single walled tank with limited access and poor containment, evidence of fuel spilled on floor (Placencia)

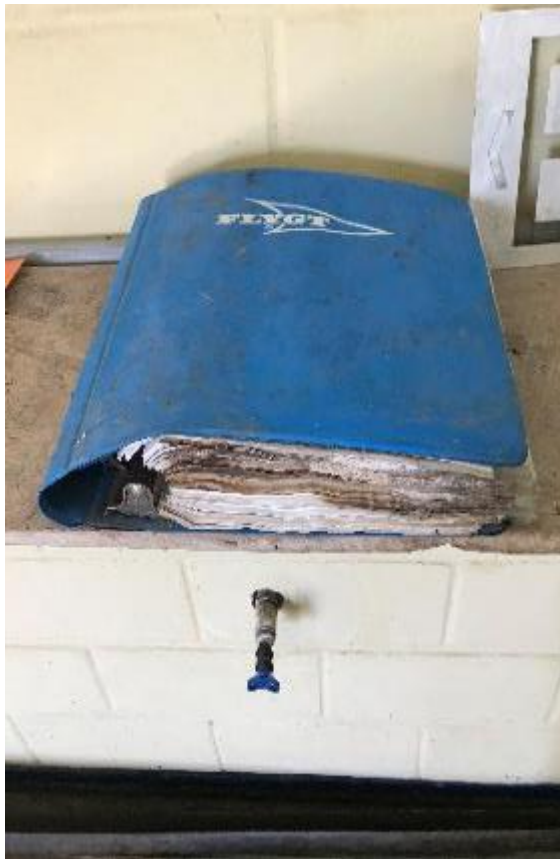
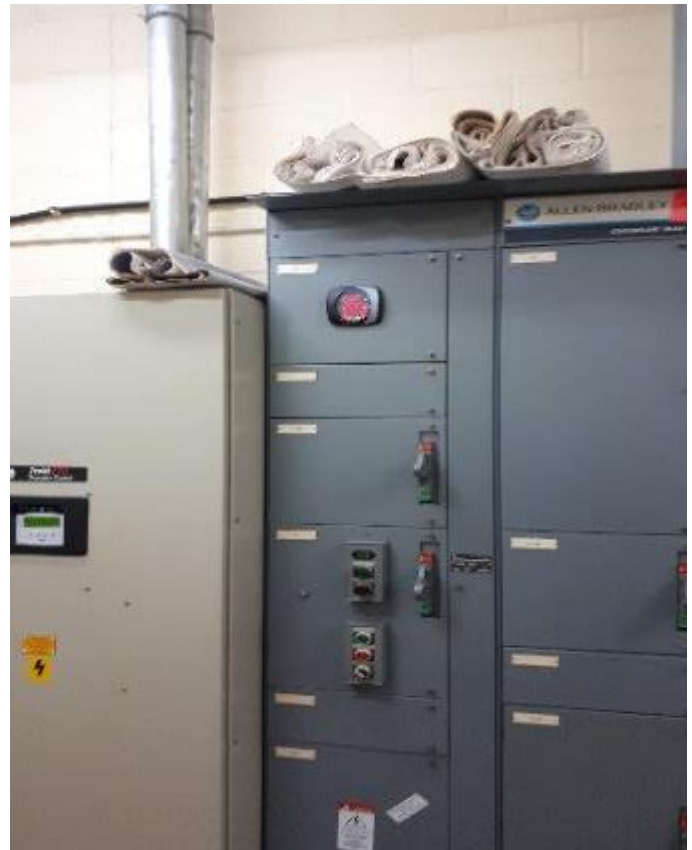
Sewage pumping station manual and drawings from San Pedro

There appeared to be a lack of knowledge of the design and operational components of some systems, particularly the older system. Original documentation must be located, preserved and shared with staff. In the absence of original documents staff should be developing as-built drawings and operational and maintenance manuals. The systems installed are not unique to Belize- in particular the drop in sewage stations. If information is not readily available, the internet should have examples that can be modified to the specific requirements of Belize.

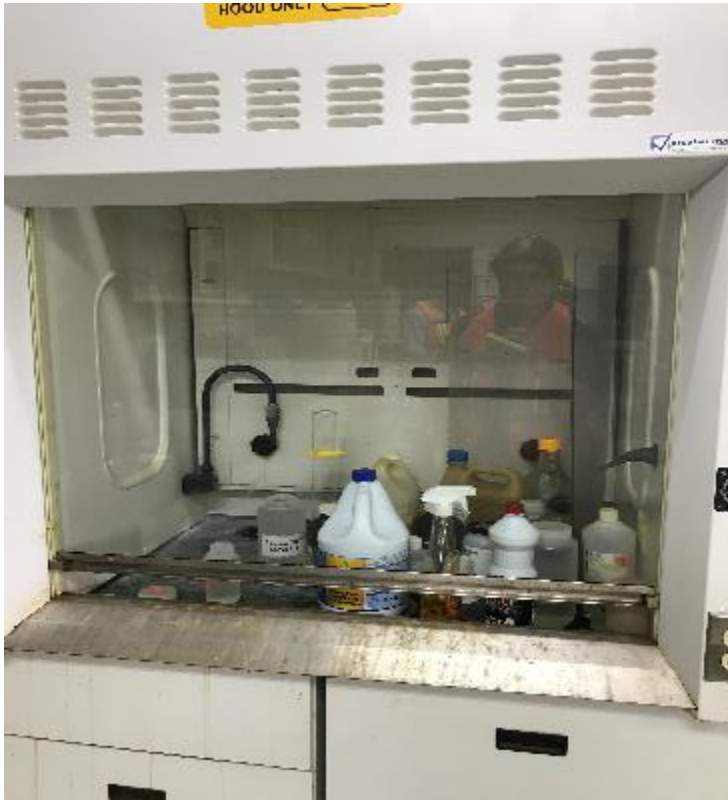
Chemical compatibility to be reviewed for under fume hood

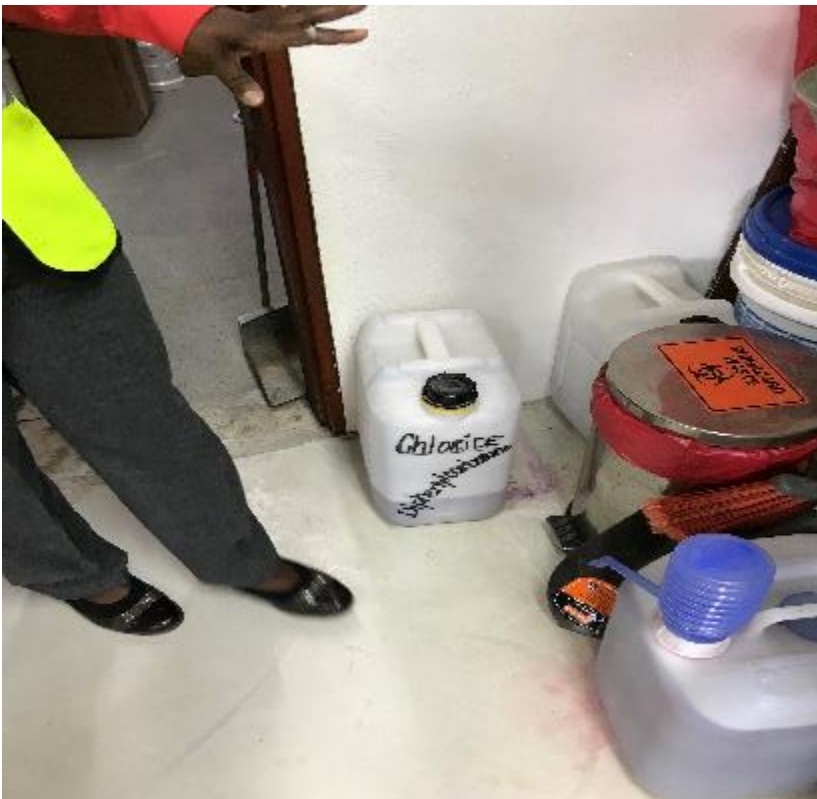
Seek an alternate location for spent hazardous chemicals
