TYT Torch Analysis

Prepared by: Caleb Russell

This report is a summary of findings regarding the TYT Torch produced in Turkey. This torch has been spotted as a “bargain brand” BR-22 and has potential safety hazards and intellectual property infringements which prove problematic for our customers and business respectively.

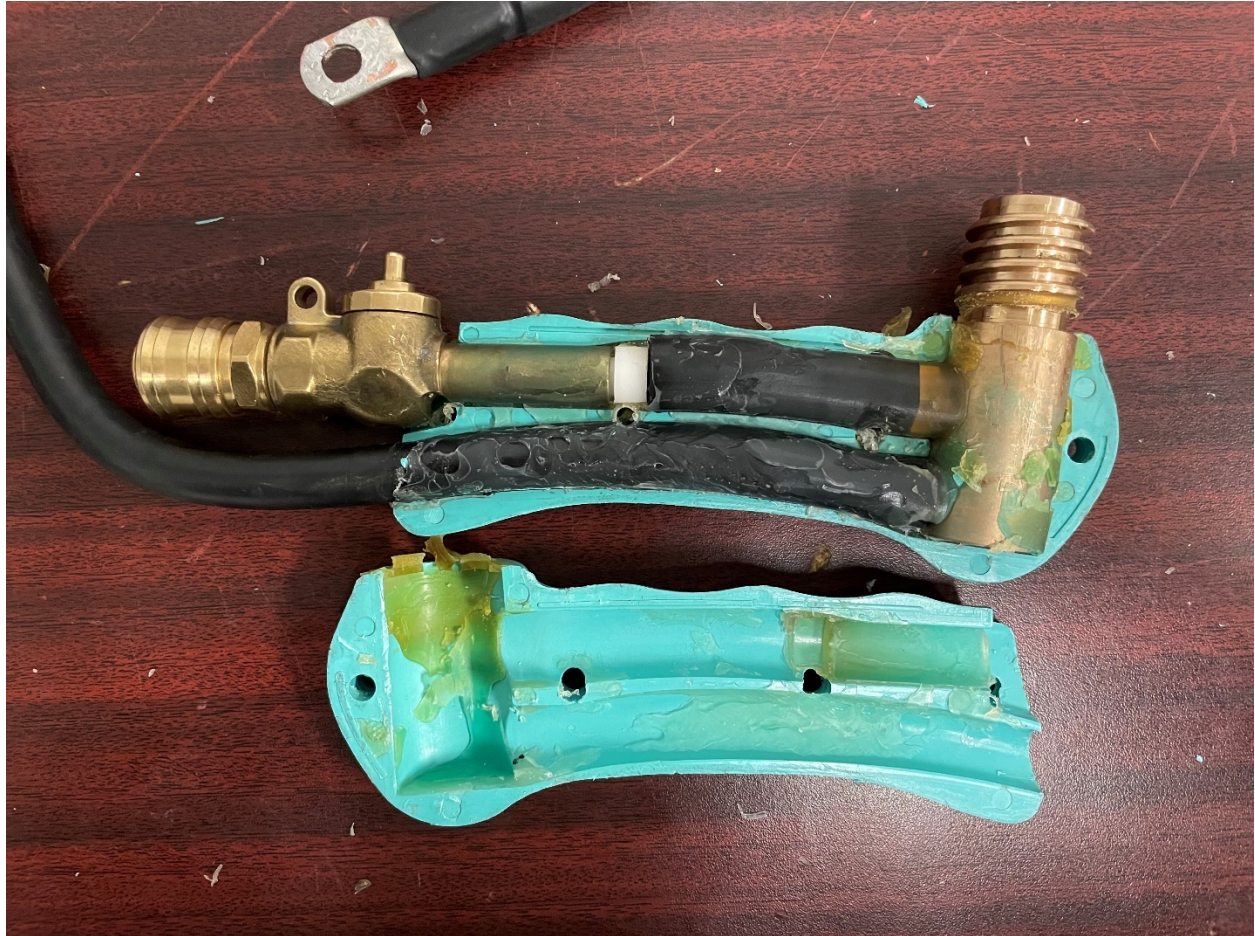
In order to run my analysis on the torch, I needed to open it up and look inside. After removing the bolts, I discovered there was an immense amount of silicon adhesive holding the whole inside together. After spending a substantial amount of time prying at the seams and using heat to soften the glue, I finally broke the casing open to find everything inside coated with a thick layer of it. Customers will find it difficult to change out or service any internal parts of this torch and will most likely not be able to return it to its original state once open which could prove dangerous if attempted.

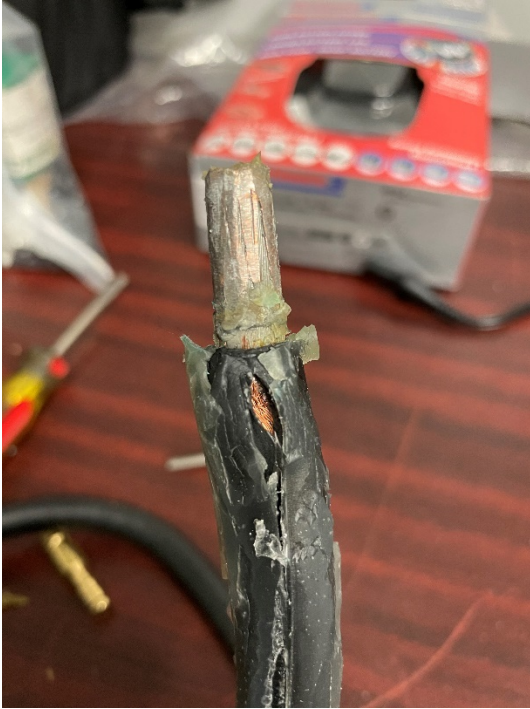
For example, when I was separating the casing, the silicon joined to the rubber shielding on the power line and tore it, exposing the bare wire within.

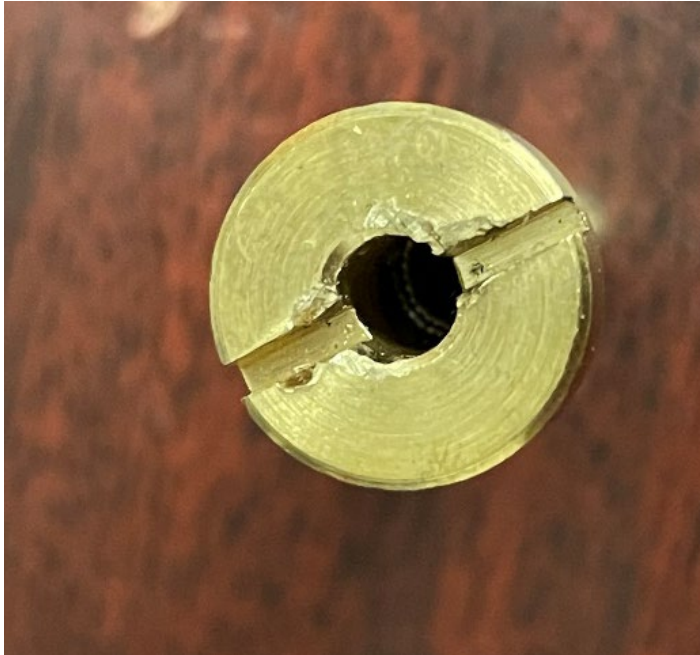
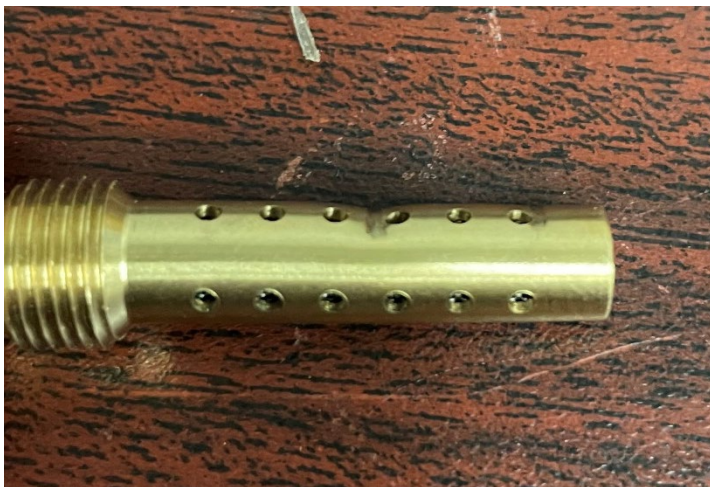
Damaged Flash Arrestor

My first attempt to remove the flash arrestor was rather tiresome. It would not budge, and the material began to chip off while I was engaging the screwdriver. It was not until I applied heat and got the case open that it was easily removable. This could mean poor material selection or that the engineers could have neglected the grade altogether.

Once it was removed, there were visible defects. The main shaft was bent as if it were compressed or hit by something prior to being installed. This means a severe lack of quality inspection in the production of the torches which are put on the market.

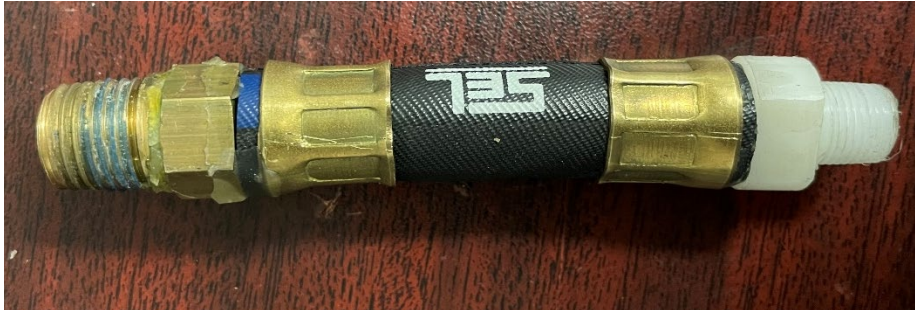
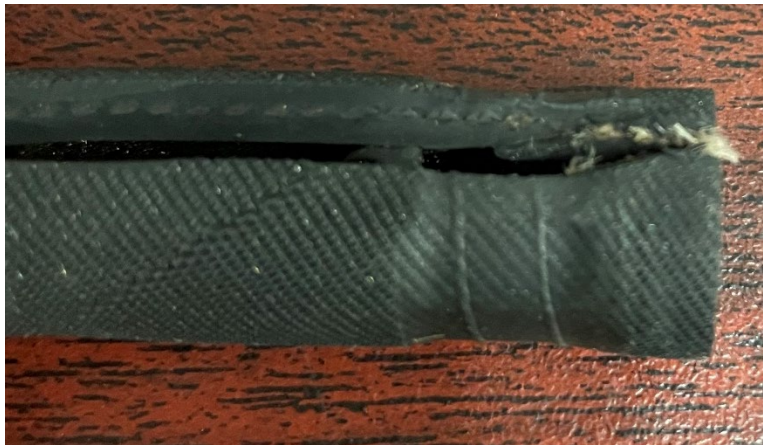
SEL SuperStream 1K hose (P/N HWB1N-K31S)

The gas line has a hose to connect the valve to the torch head, similar to our design, however, this material is purposed for hydraulic systems and is rated for a max heat of 212 deg F. I have requested the MSDS for these hoses from the manufacturer and will check to see for sure whether combustibility is a concern. (See results at end)

Potential combustible materials (foam bushing, rubber washer, hose) were exposed directly to an open flame to observe their reactions. While the Foam ring and hose remained engulfed for a short period afterwards, ultimately, they self-extinguished after a few seconds.

The foam ring and rubber washer do not raise any concerns as they will most likely become extinguished by the water in their immediate surroundings. The hose however, burned for long enough to be concerning (15 seconds). If a flame or spark were to make its way into the O₂ line, the hose could erode enough to cause a leak or catch flame.

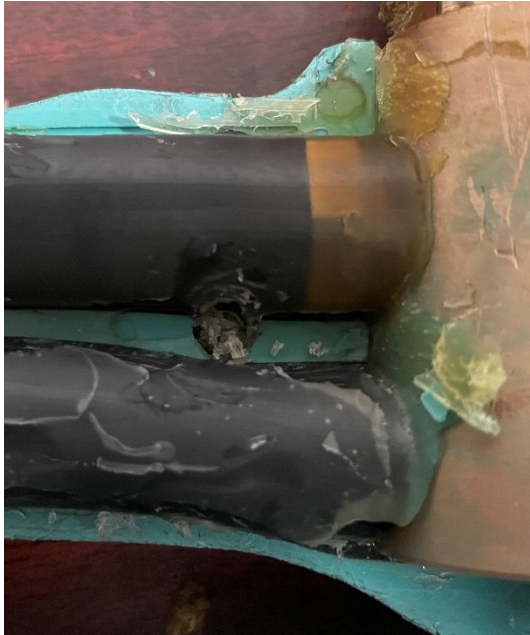
In addition to material concerns, there was a perforation in the outer protective layer for the hose caused by drilling out the hole for the screw which held the casing together. If this operation were to affect the hose itself, it could cause a rupture in the oxygen line.

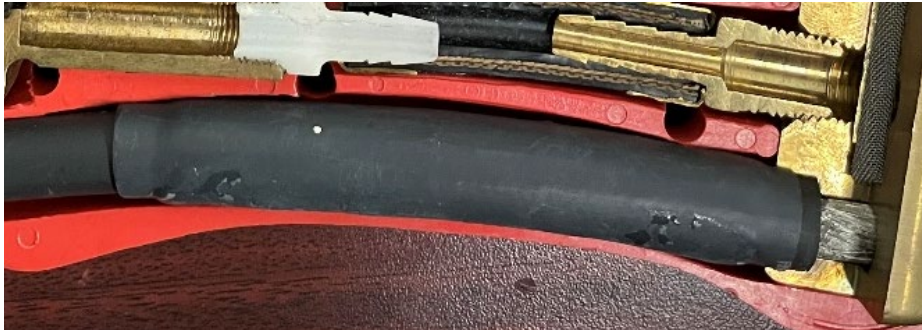
Wire Shielding

Unlike our BR-22, the power line lacks shielding within the torch handle. This could allow the power to cause a voltage between the diver's hand and the wire and produce a shocking sensation.

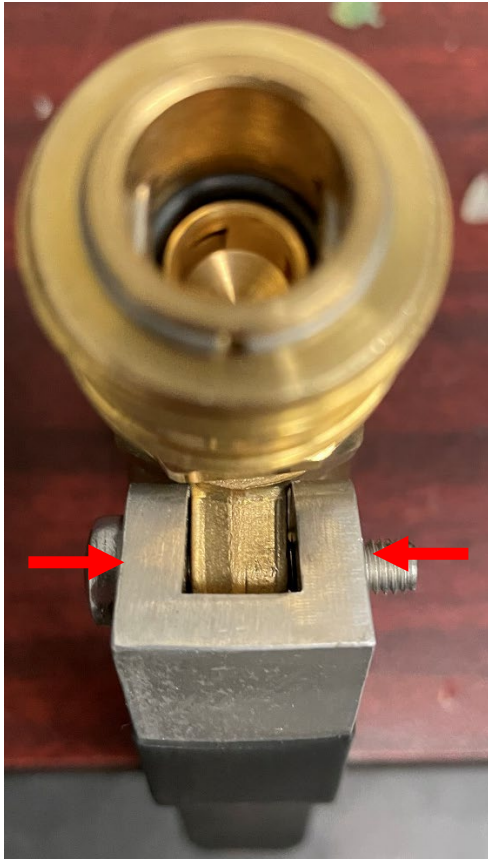
Aluminum Trigger

The trigger is made from cheap aluminum and is not sized correctly. It was made far too large for the mount they designed which means it is more likely to bend out of shape causing failure in the future.

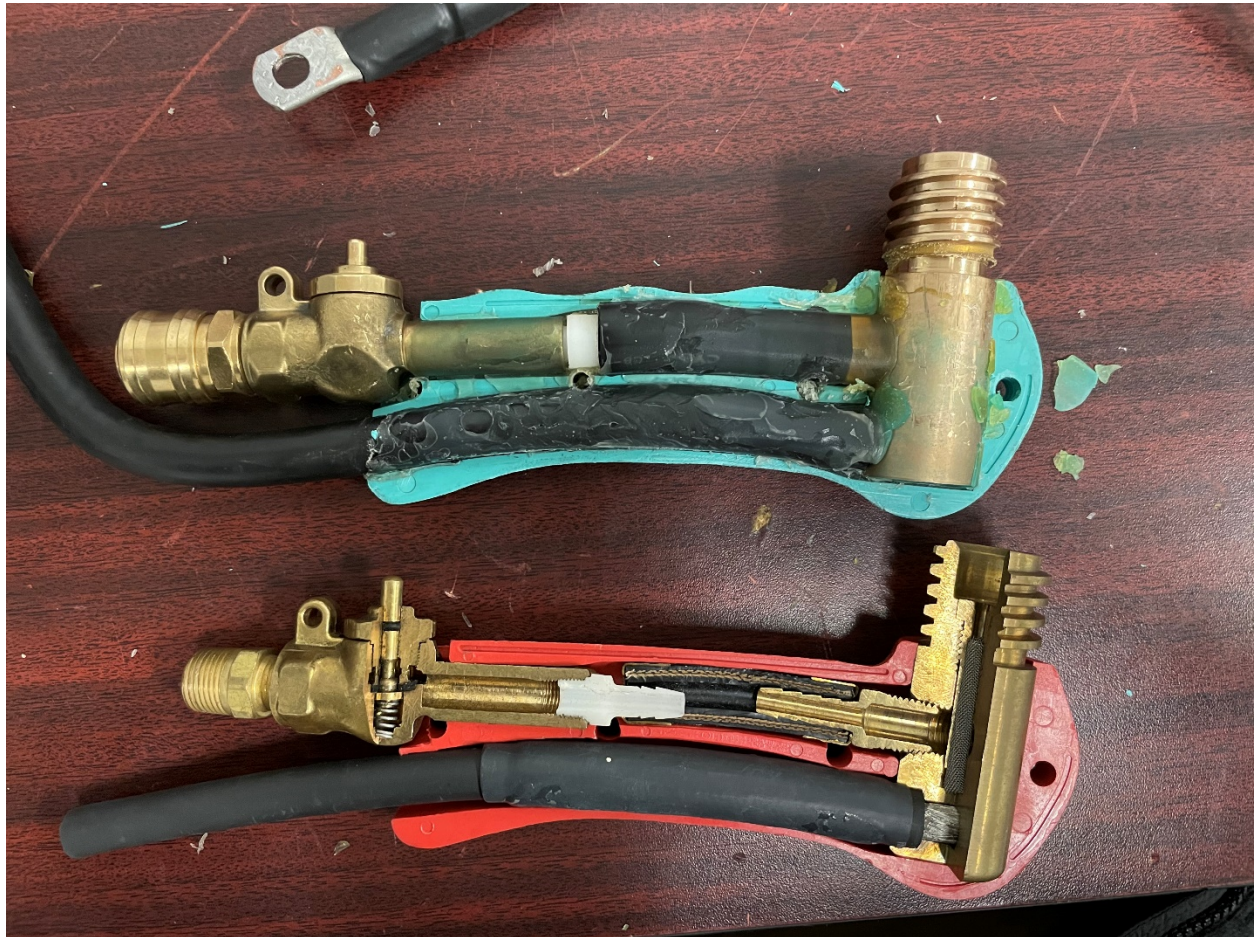
These two torches are very similar in many ways. Below is an image depicting both torches next to one another. The casing, flash arrestor, head, and overall assembly concept are the most alike (the collet nut thread is similar enough to make the parts interchangeable). See detailed comparisons below. Looking into design patents filed by Broco for this design will allow us to take legal action against this other torch and lay claim to any profit they may have stolen.

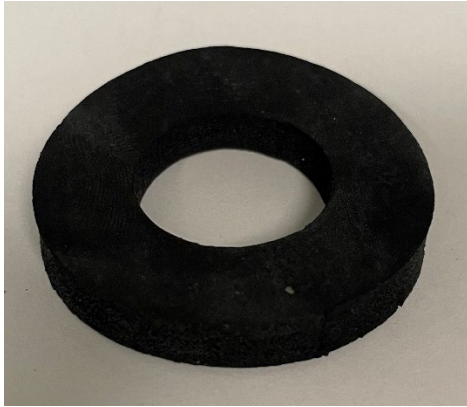
Foam Bushing

There is a foam ring between the body and the collet nut. This may be for insulation purposes but could potentially be made from a combustible material.

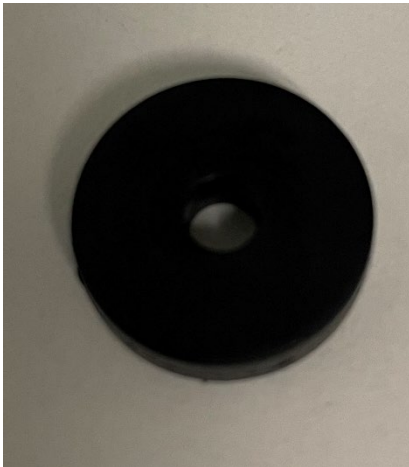
Rubber Washer

Like the BR-22, there is a black rubber washer which sits under the collet that provides a sealed surface for the rod to rest against. This will also require a combustion test or further research to determine material safety.
